QUINQUENNIAL INSPECTION REPORT 2024

FAVERSHAM GILDHALL
MARKET PLACE FAVERSHAM
KENT ME13 7AG

DANIEL MARTIN *BSc, MA, MRICS*
CONSERVATION ACCREDITED CHARTERED SURVEYOR

Date of inspection December 2024

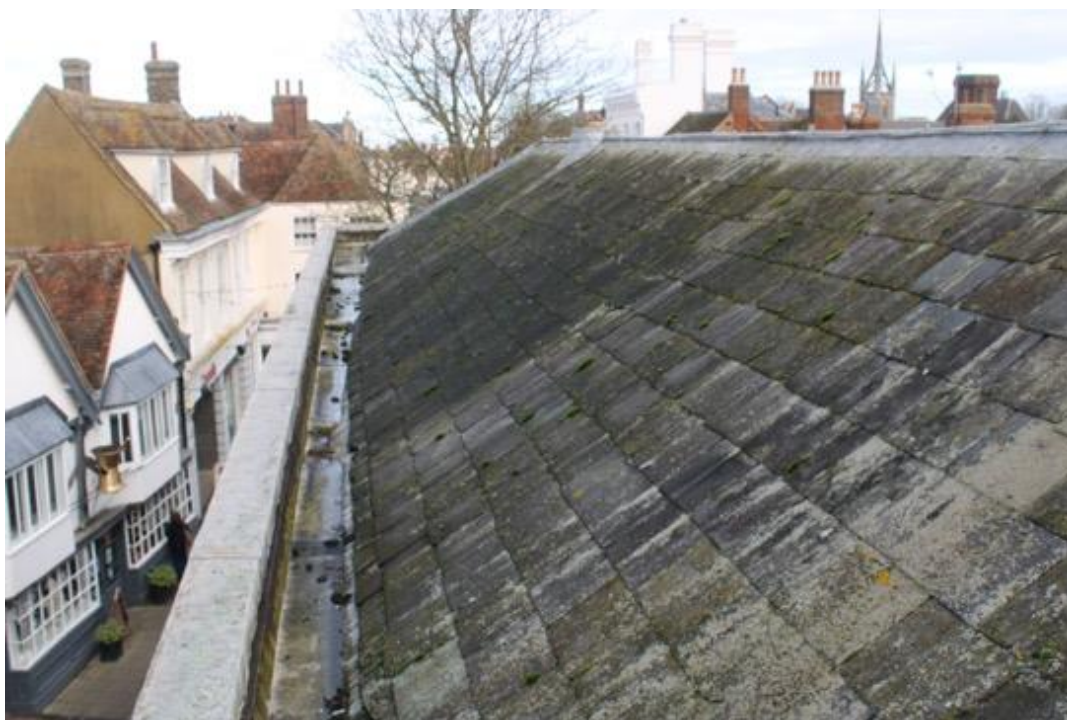
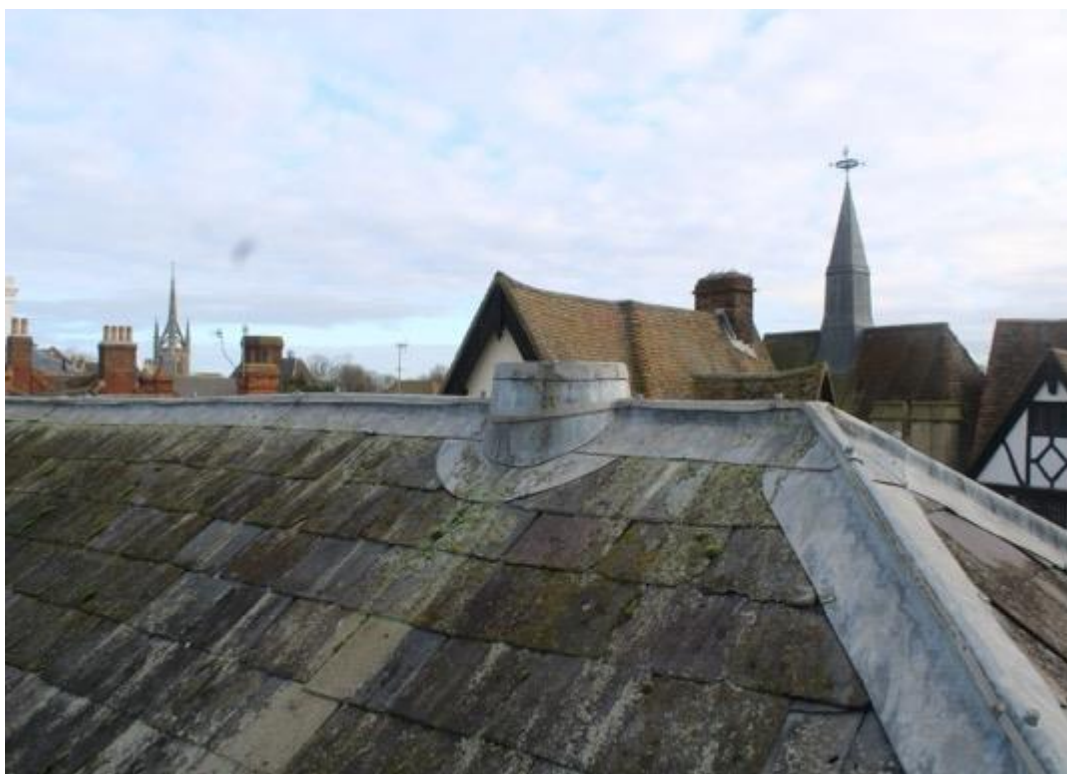
The slates which may already have been salvaged and reused are deteriorated. A large number have slipped and been replaced or refixed using supporting strips of lead known as tingles. This suggests that the nail fixings are corroded. The problem will progressively worsen with time.

The lead coverings are in generally satisfactory condition although a closer inspection and localised opening-up is advised. There is evidence of water ponding which may be the result of decay and settlement of the timber lining and/or structure supporting the lead.

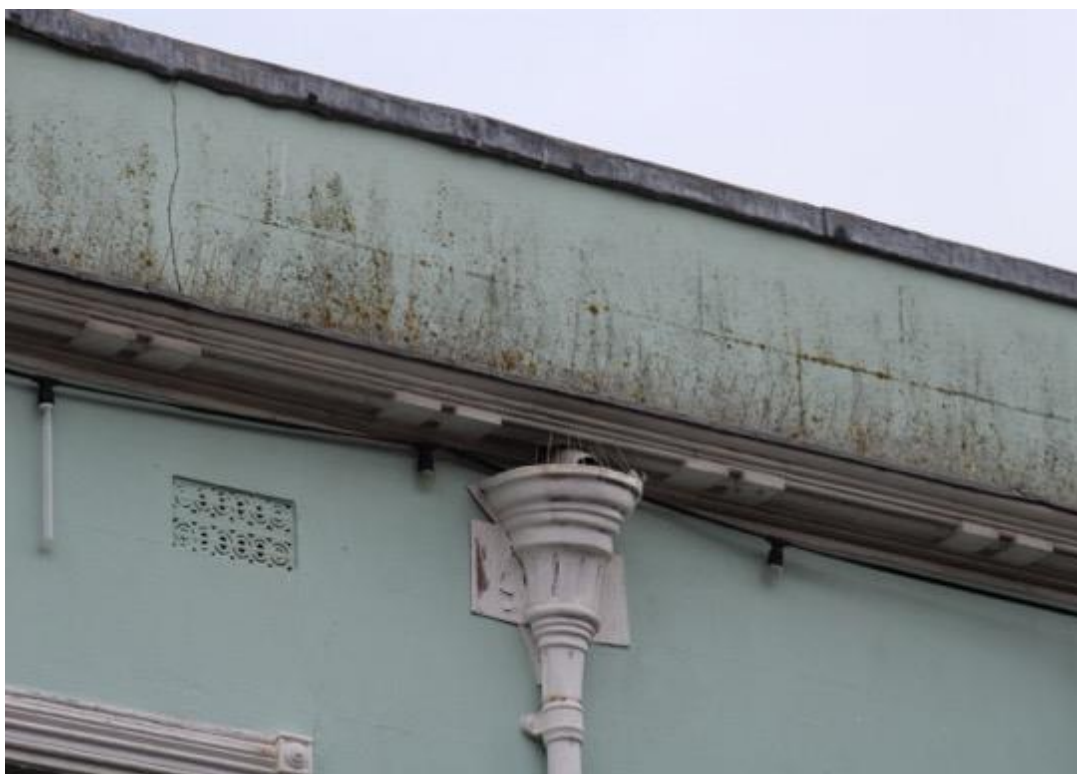
The timber weatherboarding to the inner face of the parapet is an unusual detail. It suggests that the wall behind is timber framed. Any failure of the lead lining is hence increasingly likely to result in decay. It is therefore critical that the gutter is maintained in good condition. The staining on the front face of the parapet wall indicates that there are issues of water ingress. The lead coping to the head of the parapet also needs to be closely examined.

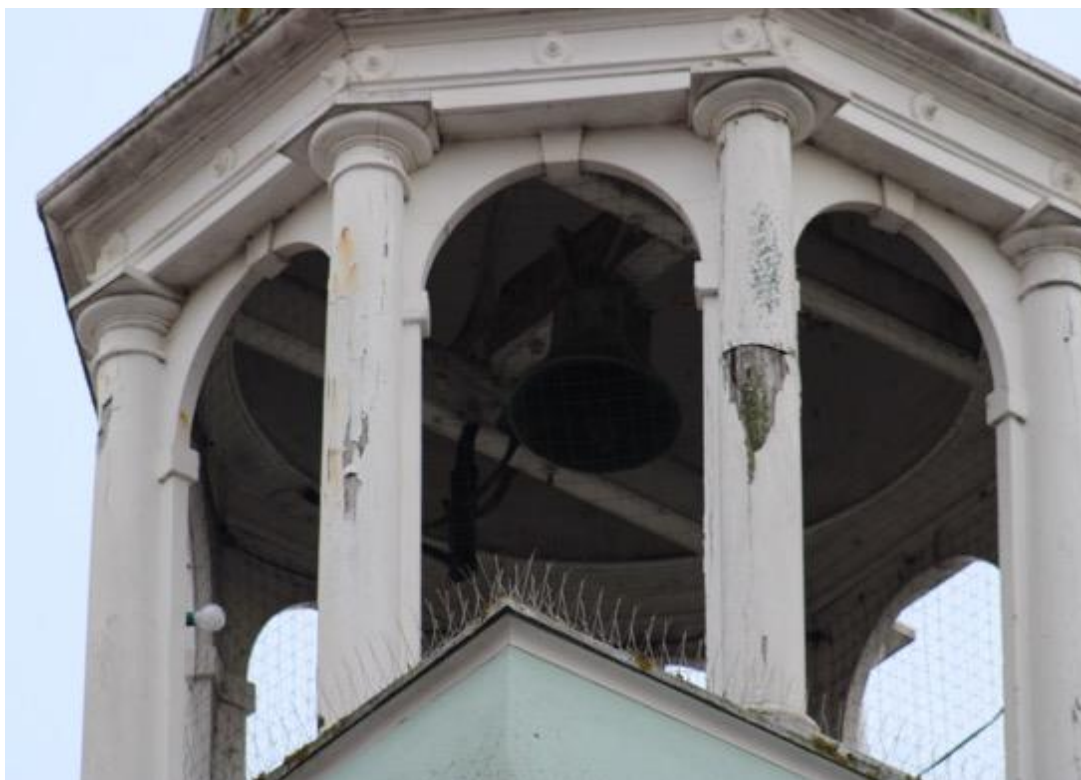
There is evidence of decay to all parts of exposed timber framework but a closer inspection is needed to quantify the extent of deterioration.

At this stage it is felt that the repairs are likely to be localised but extensive. There is evidence to suggest that earlier repairs have been carried out and the failures are occurring at the interface between the original and new wood. The choice of wood for carrying out the work is crucial to the long-term survival of pieced in timber repairs.

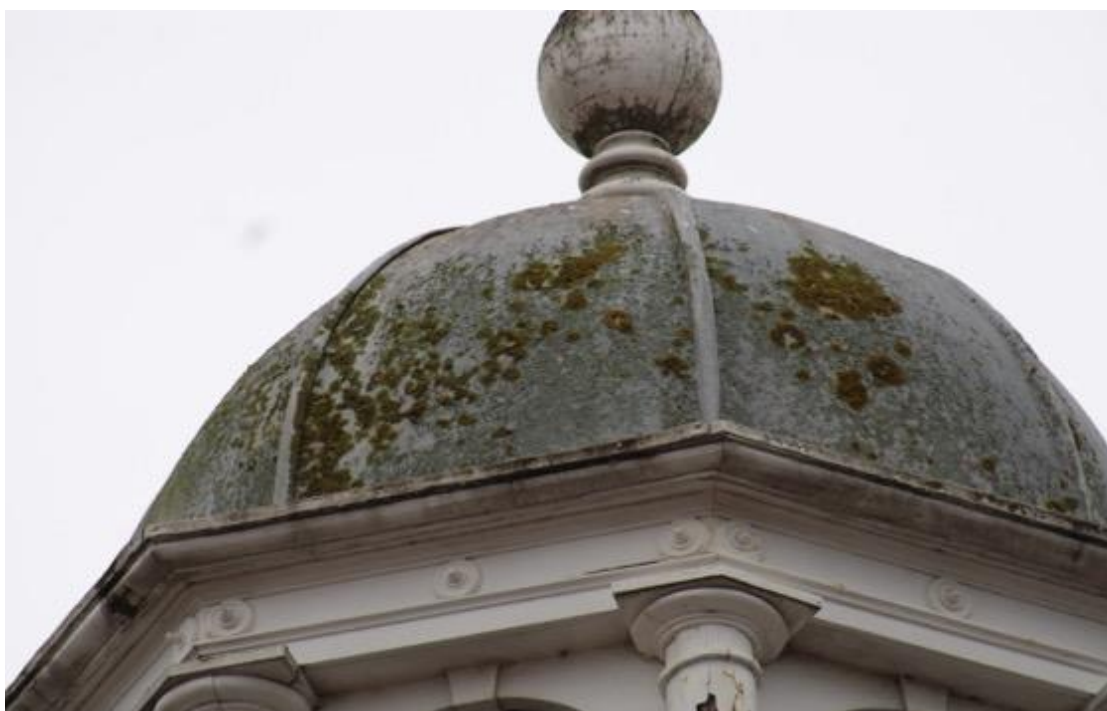
A lead lined gutter appears to run around the perimeter of the dome above the ring beam. The structure immediately beneath this gutter will be especially vulnerable to decay. The arrangements for disposal of the water collecting in the gutter are unclear. The outlet is likely to be blocked.

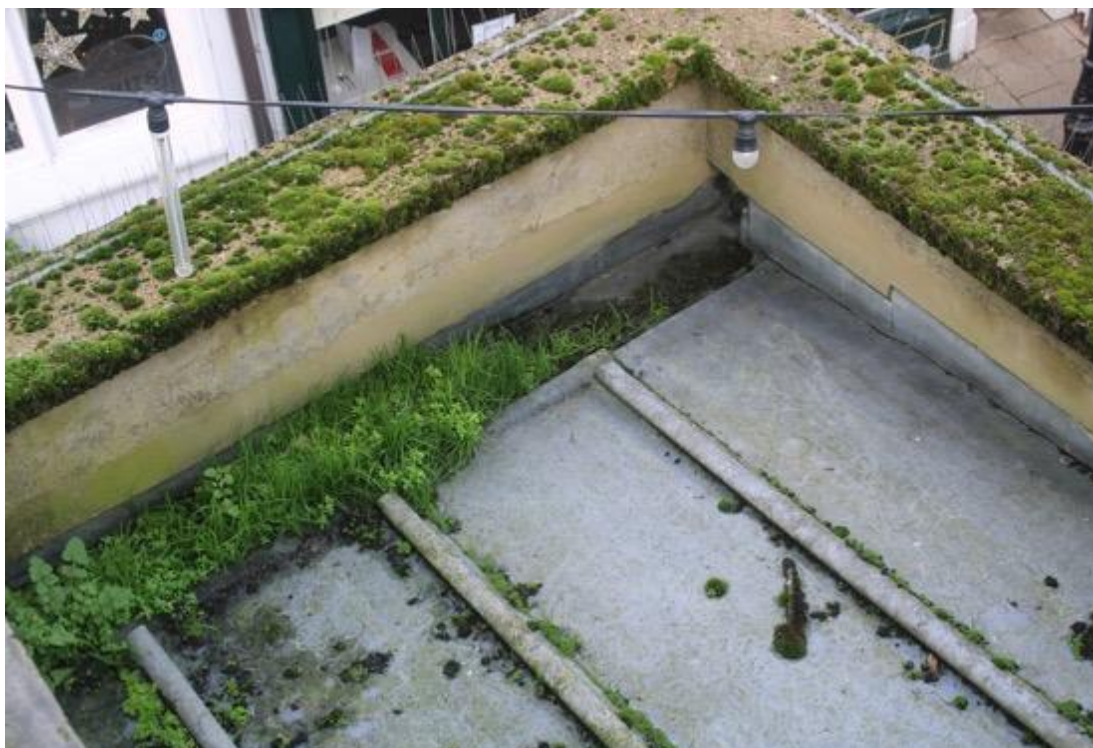
The lead appears old and is laid in oversized bays. Repairs may be found necessary following a more detailed inspection.

The composition of the copings is unclear. The render to the inner face of the parapet appears to be in reasonable condition.

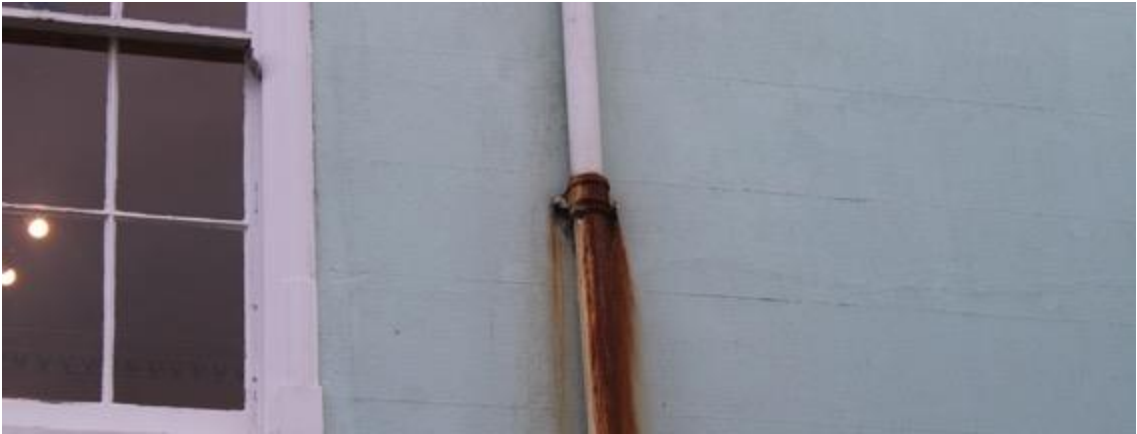
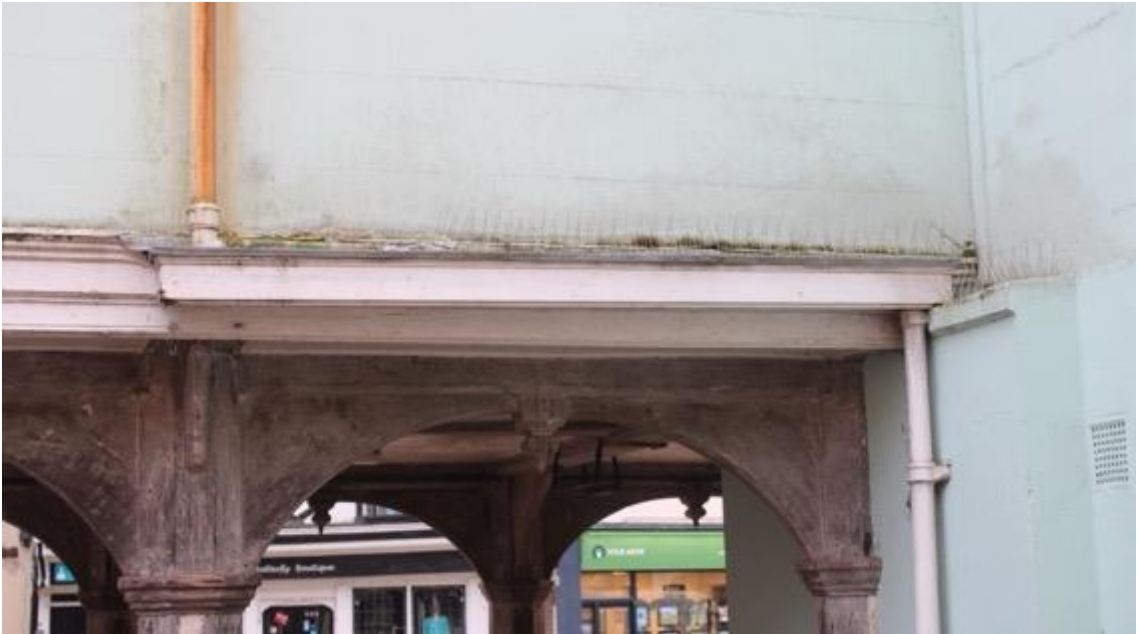
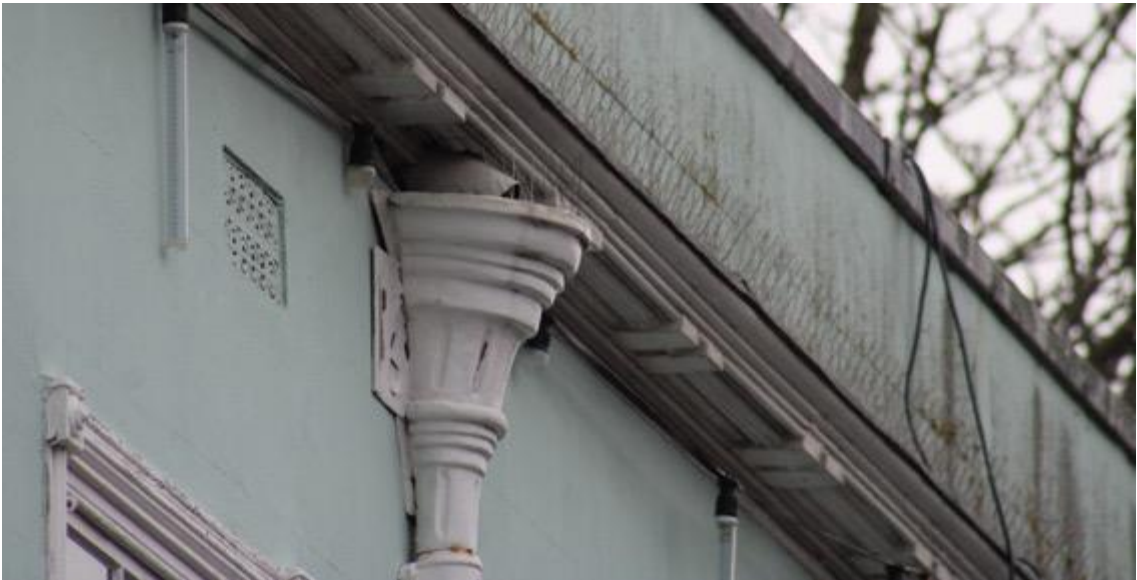
Both downpipes are corroded and leaking. Repairs and redecorations are urgently needed.

Consideration should be given removing the lead lined gutter on the west elevation and replacing it with a pipe. It has been reported to be a problem in successive QQI reports. The change would require Listed Building Consent.

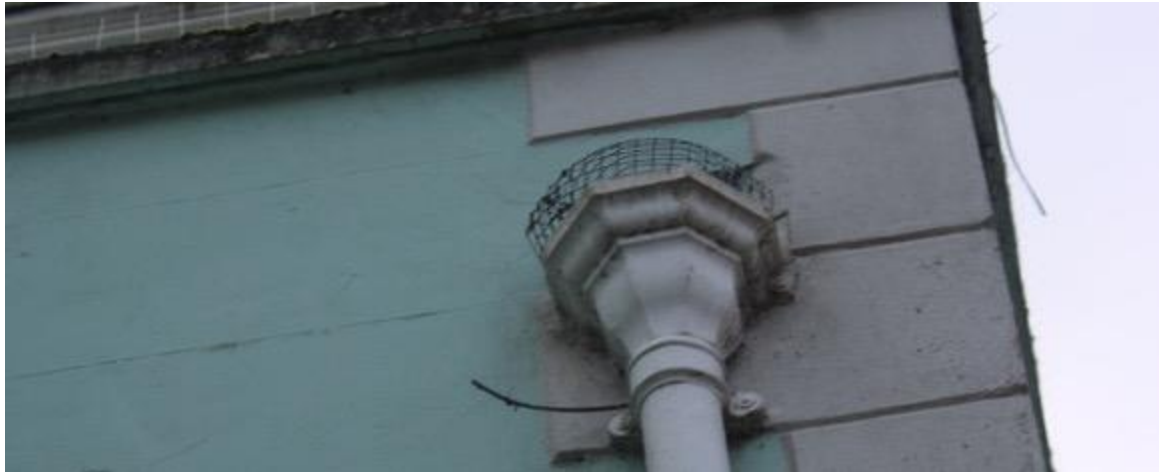
The roof is served by a single 75mm cast iron circular downpipe with a simple iron hopper head discharging onto the ground.

Decorations are overdue.

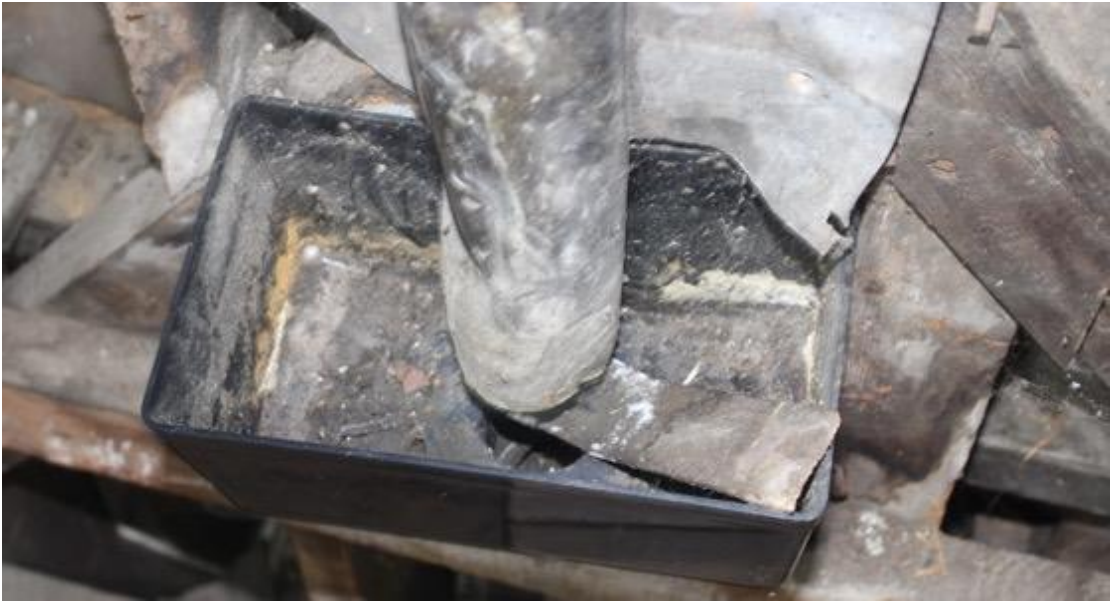
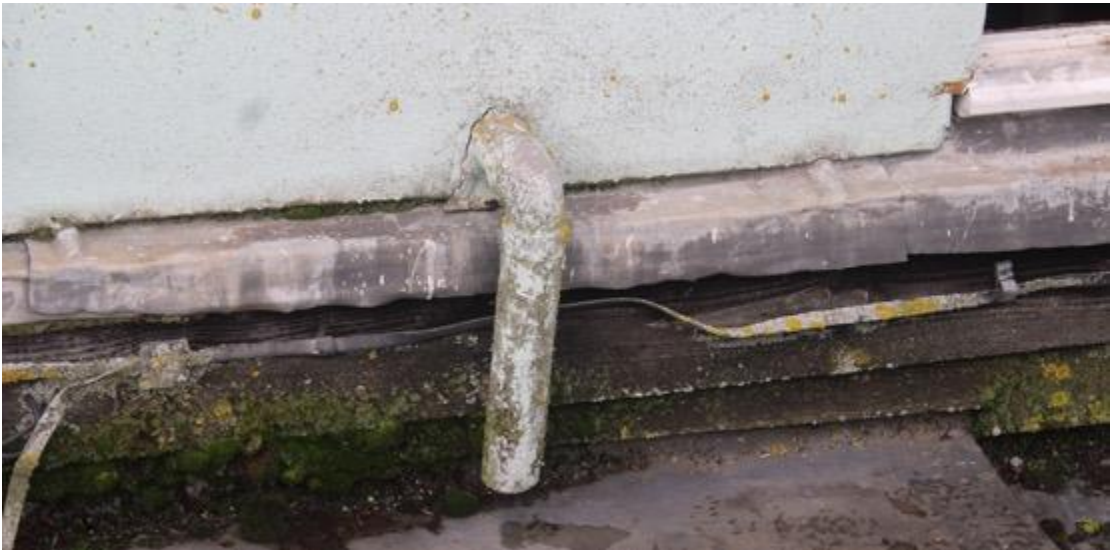
All downpipes and hoppers need to be redecorated. They are in poor condition.

Defective rainwater goods are the primary cause of dampness in buildings and commonly result in decay to timbers buried within the thickness of the walls of old buildings.

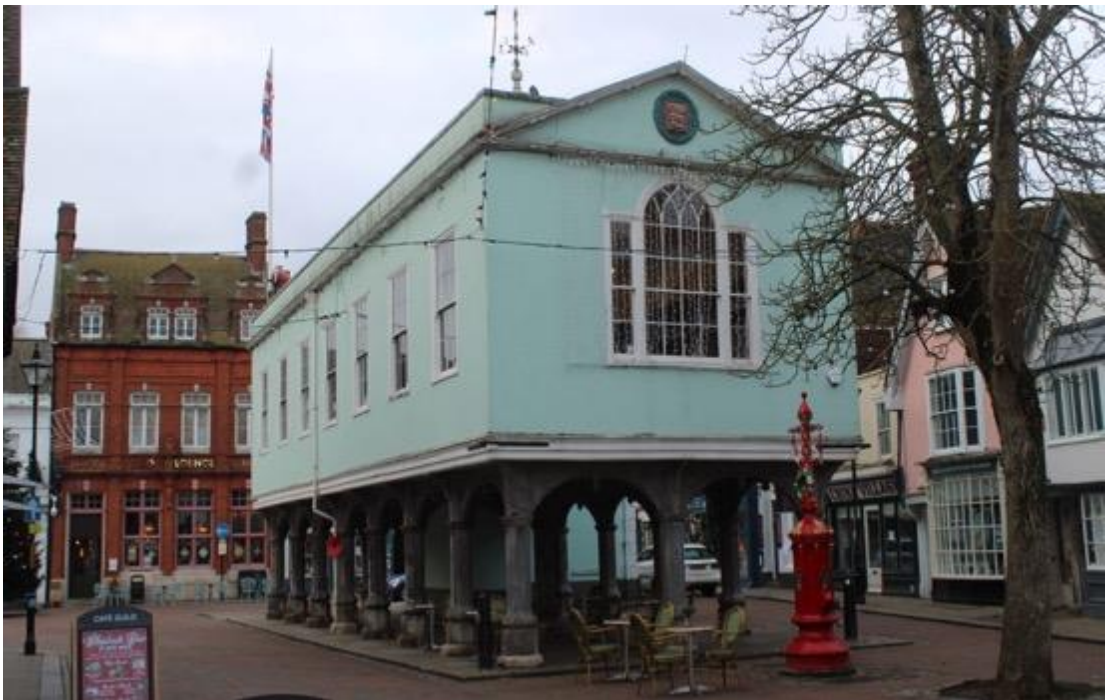
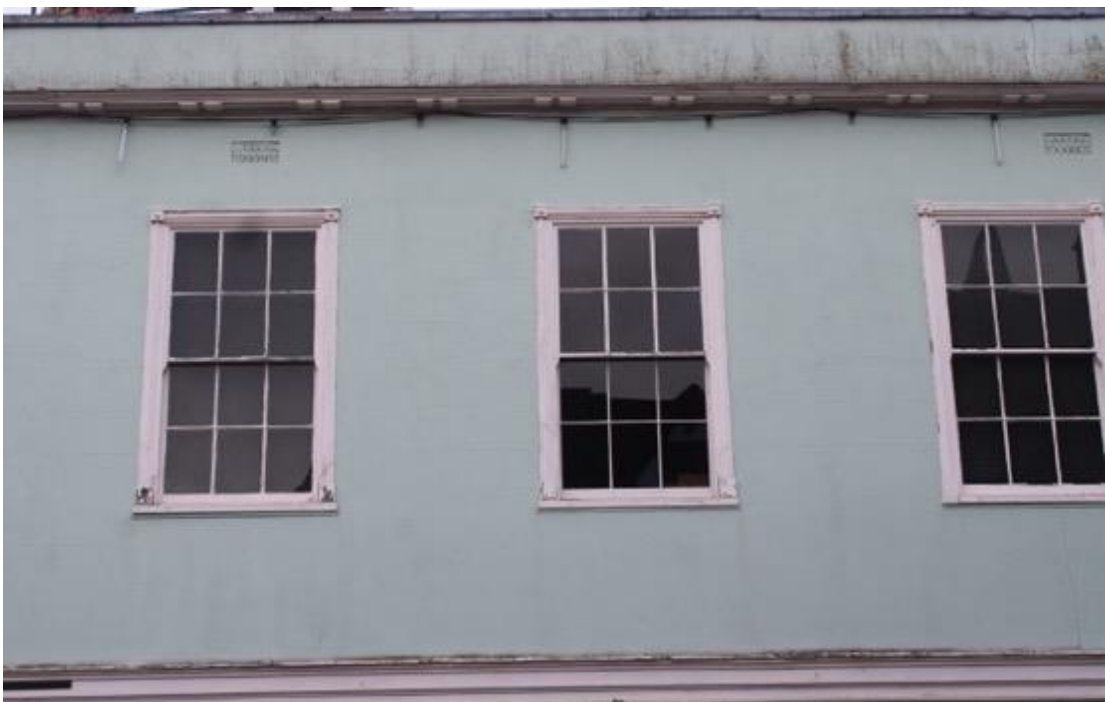
There are non-structural hairline cracks above and below some window openings. They should be cut out and filled as part of routine preparation for redecorations.

The staining at parapet level however demands further investigation. It may be an indication of more serious problems.

Redecorations are overdue.

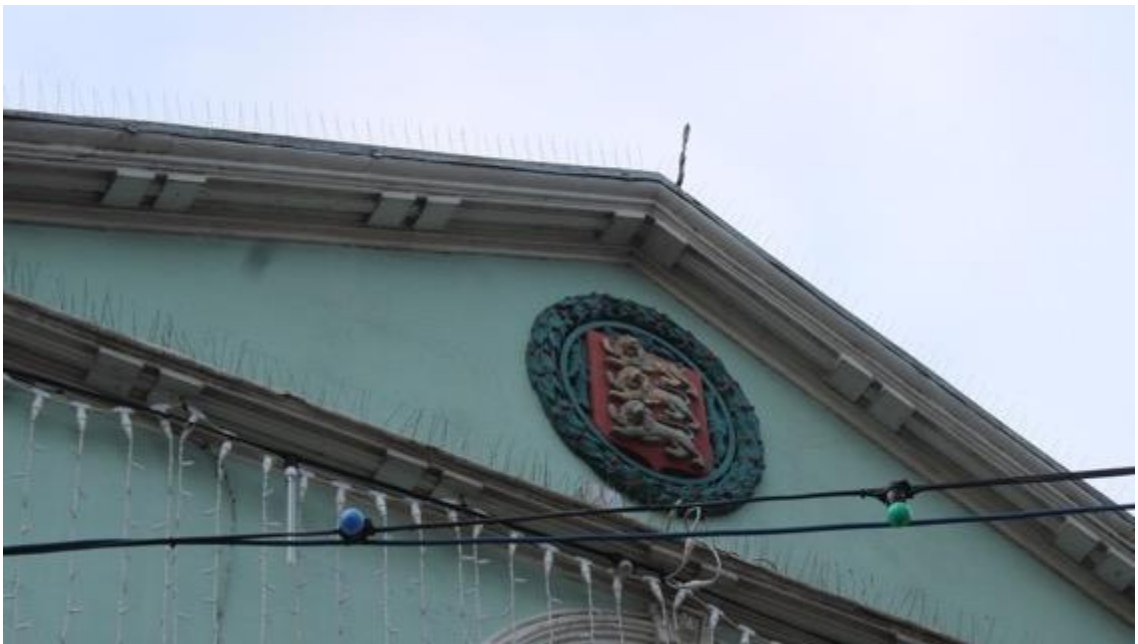
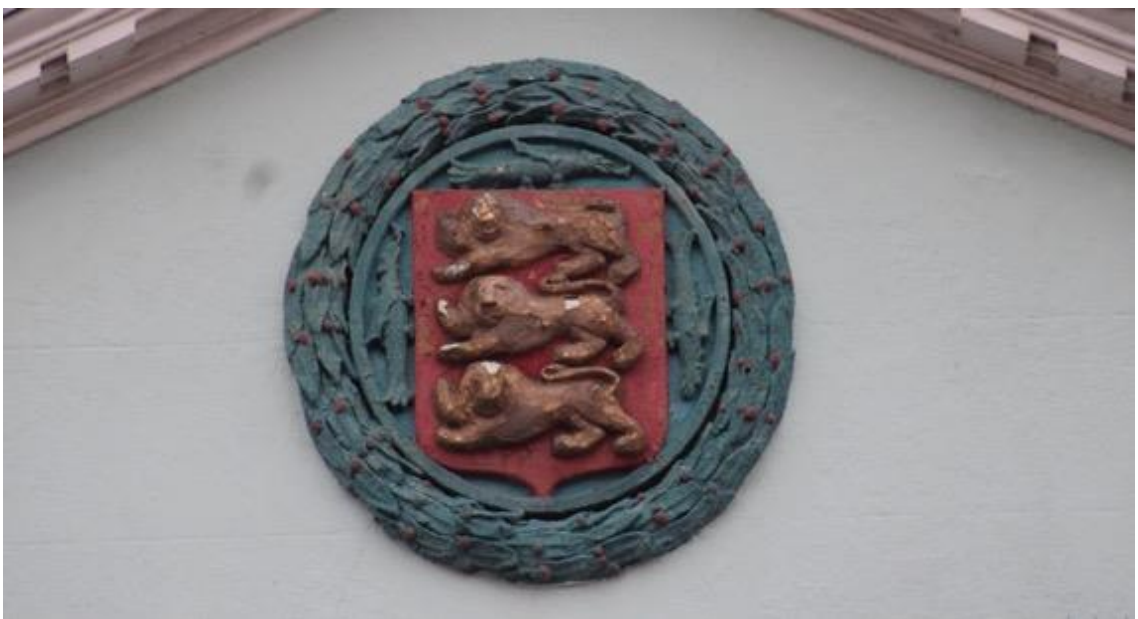
There is a three lions yellow plaster motif on a red background in a green painted wreath set in the tympanum to both pediments. The detail is eroded and paintwork or poor quality.

Analysis of the paint colours is recommended together with careful consolidation of the plaster detail.

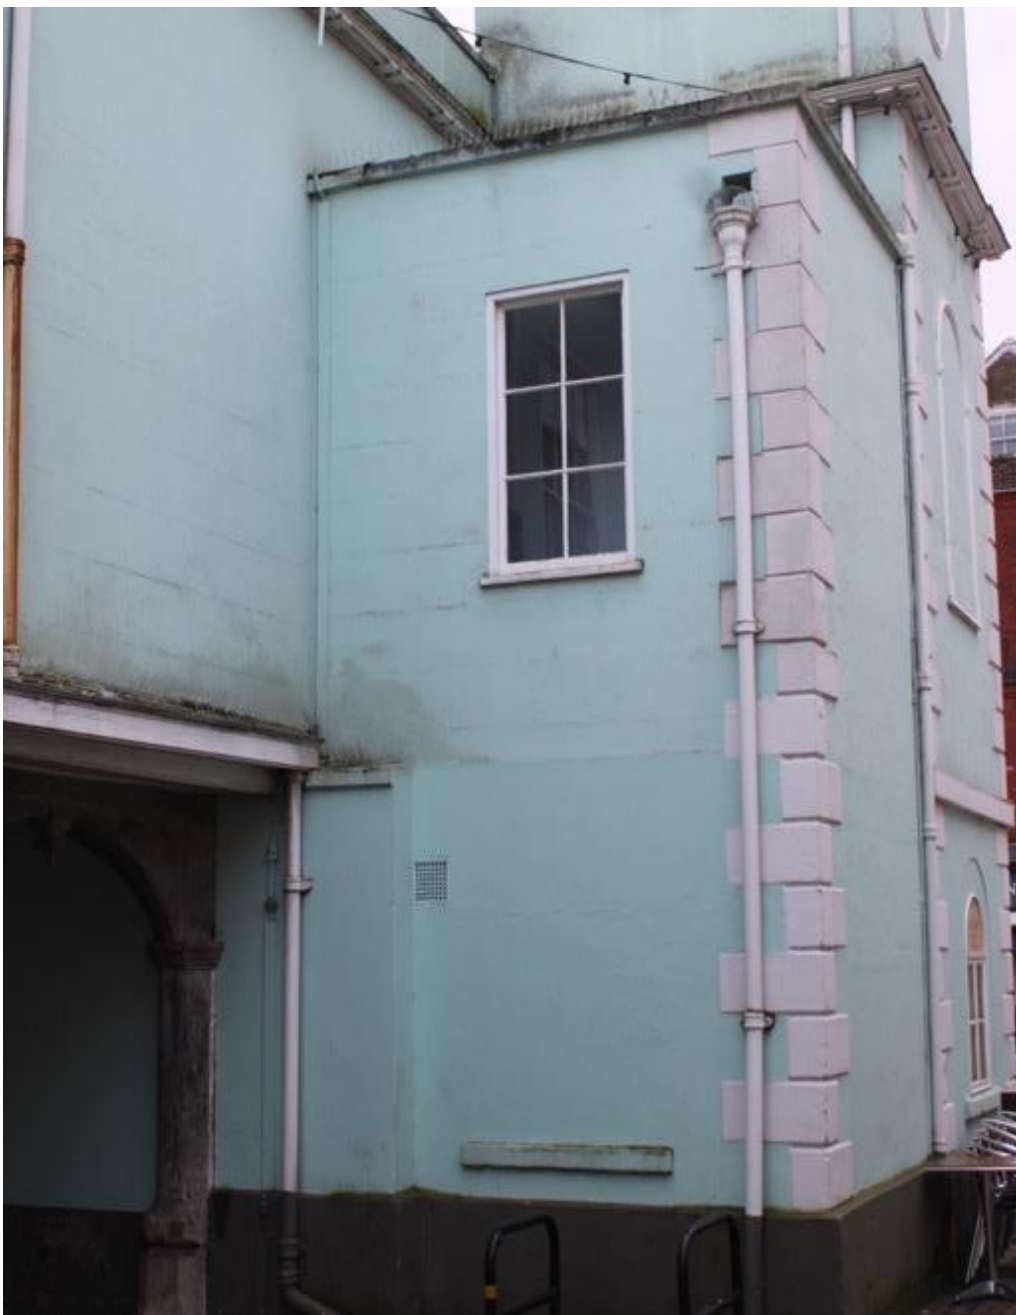
The coping is stained.

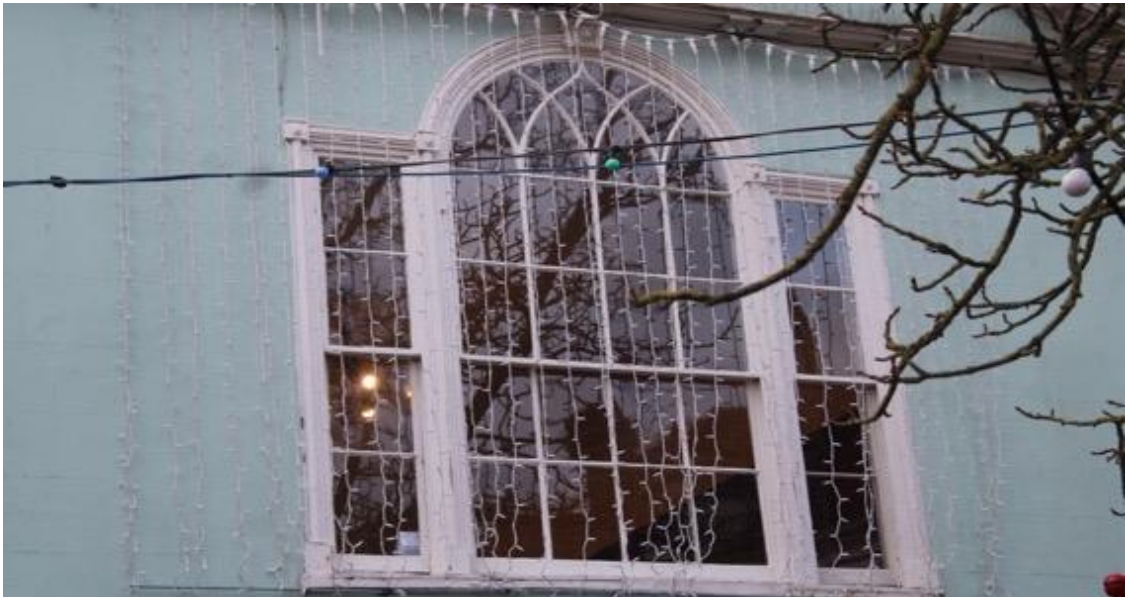
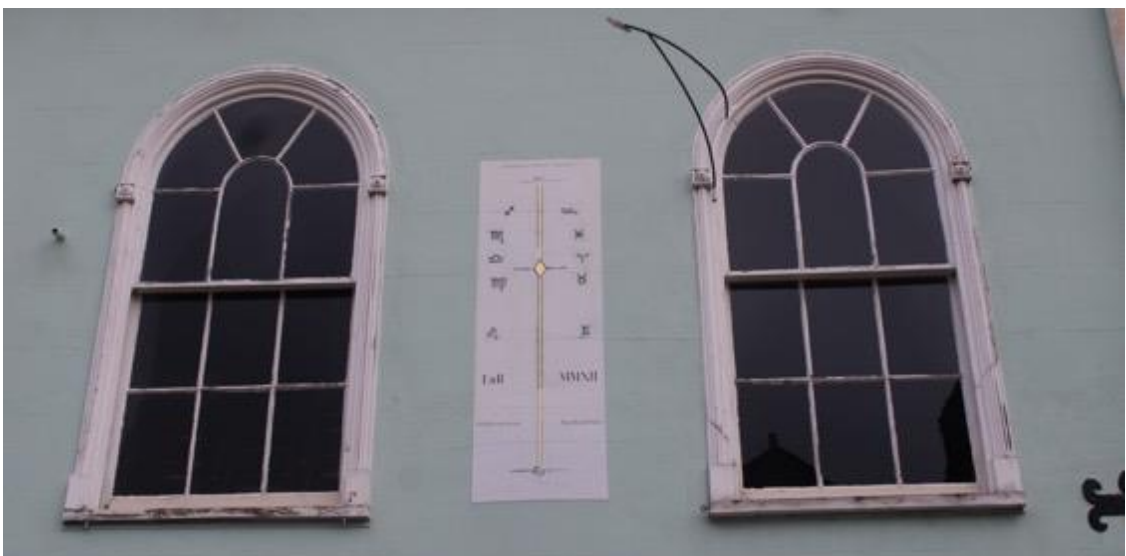
Redecorations are overdue.

Widespread previous repairs and limited localised decay. Timber for replacement repairs should be carefully selected and carried out by carpenter/joiner rather than a painter/decorator.

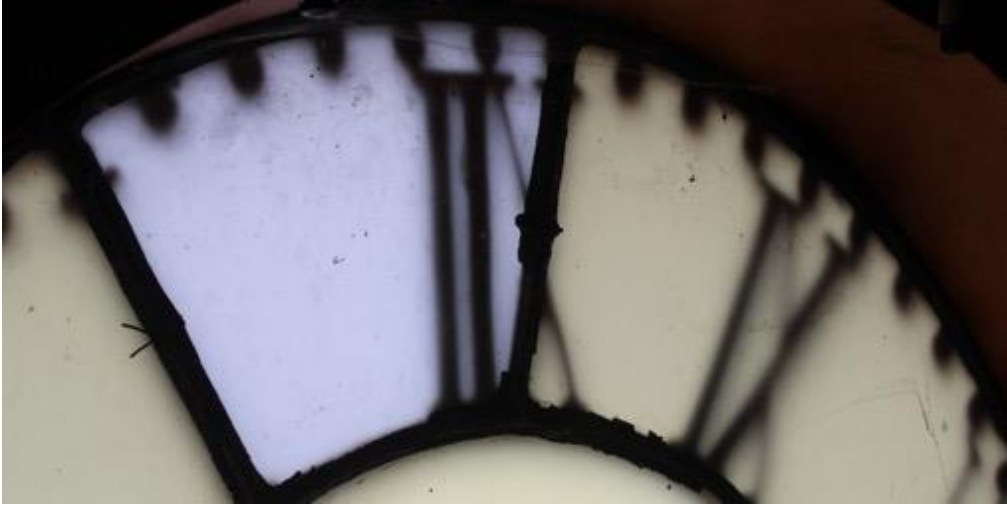
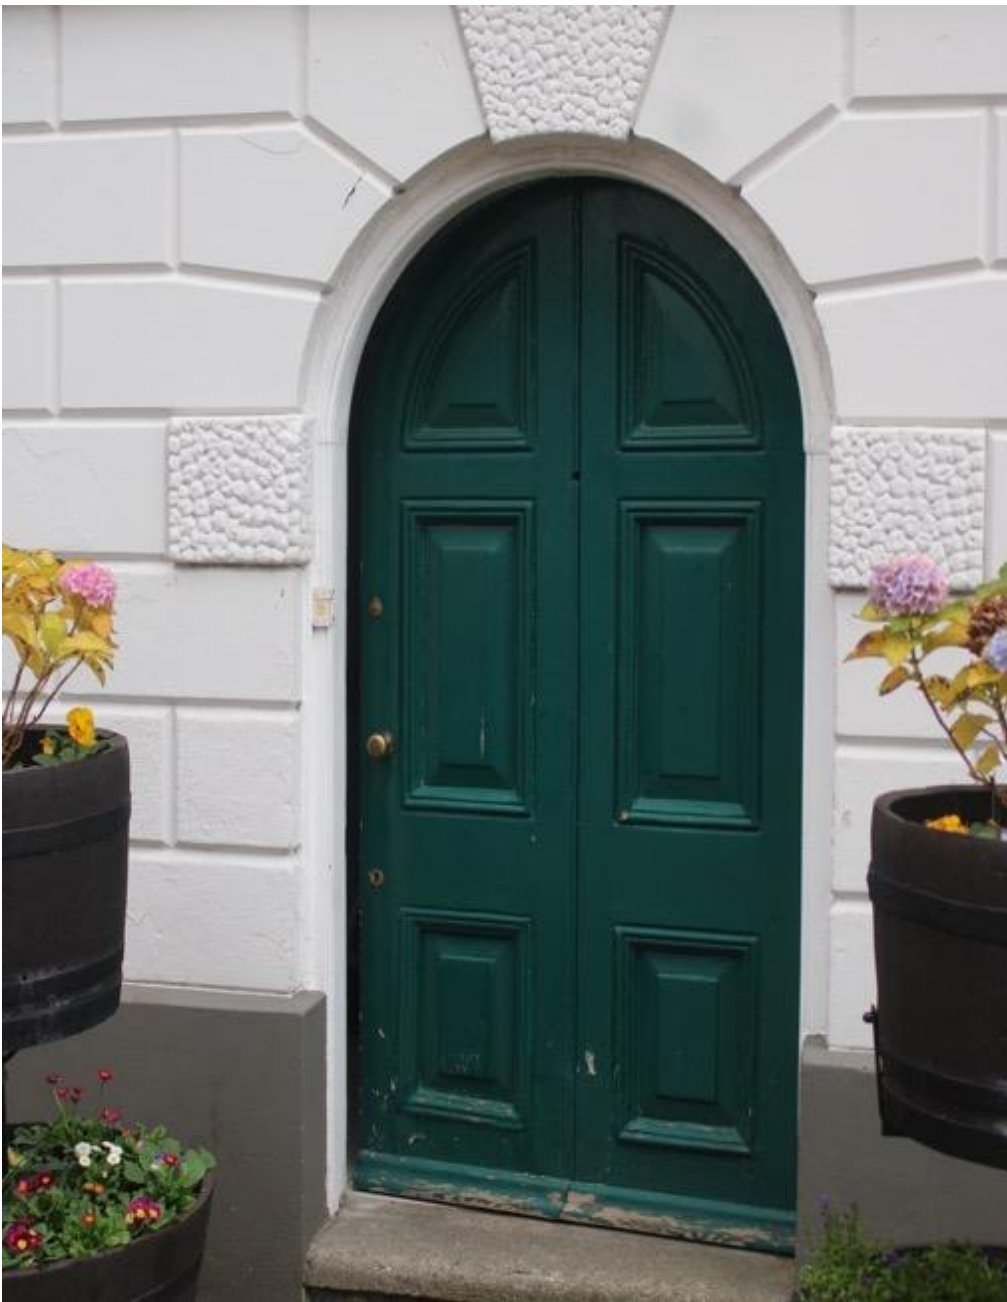
The obscured glass to the kitchen is poorly matched and should be replaced to a uniform pattern.

The replacement white glass to the clock face is poorly matched and should be replaced.

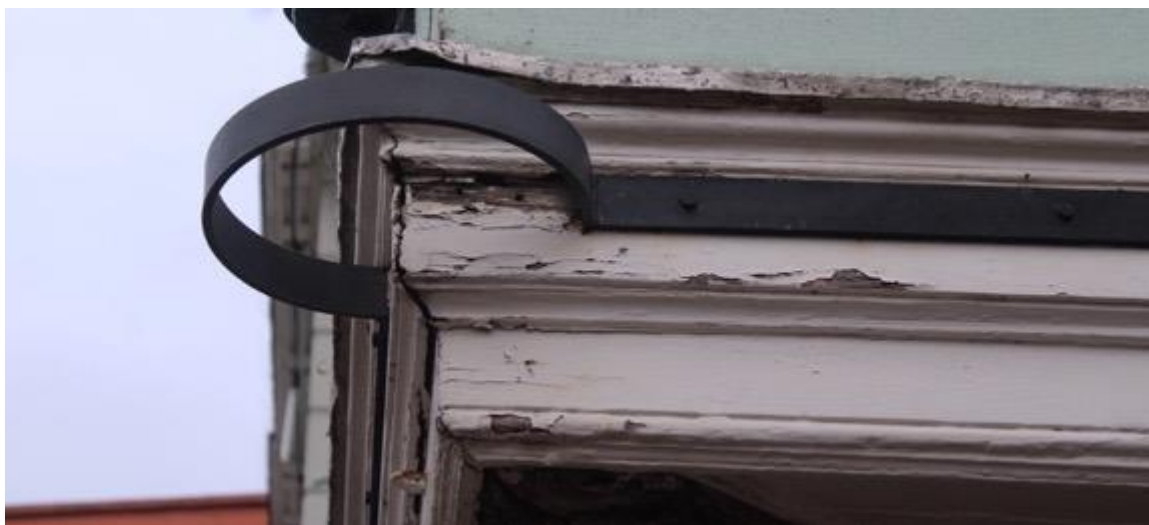
The timber needs redecorating. A closer inspection is likely to reveal decay.

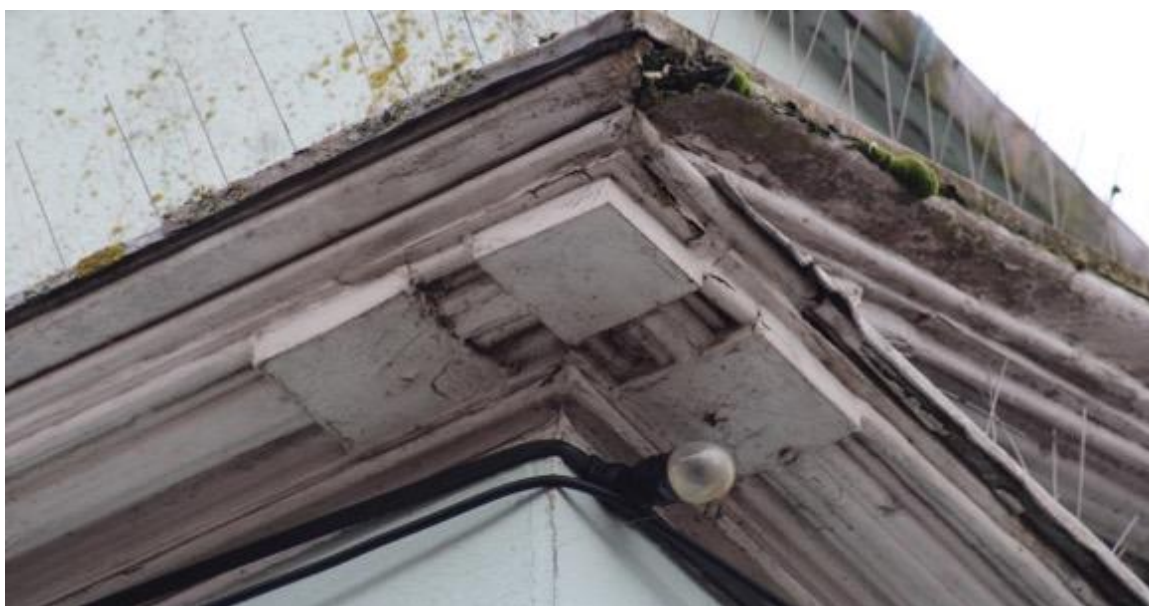
The lead coverings need redressing, and some lengths may require replacement. Improved clipping to exposed edges may be needed.

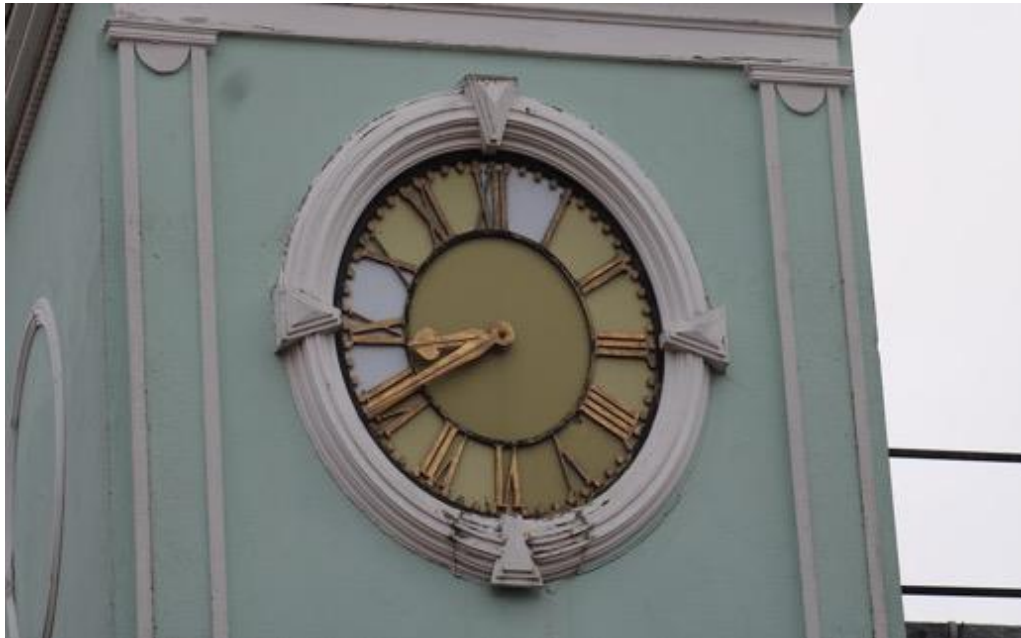
The clock face sits on the south side of the tower. It is surrounded by a moulded timber frame, the bottom section of which is decayed. The inner and outer rings of the clock face, Roman numerals and hands appear to be formed in cast iron.

The numerals and hands are finished with gold paint. They are likely to have originally been gilded.

The face of the clock is glazed. Replacement glass is poorly matched to the original.

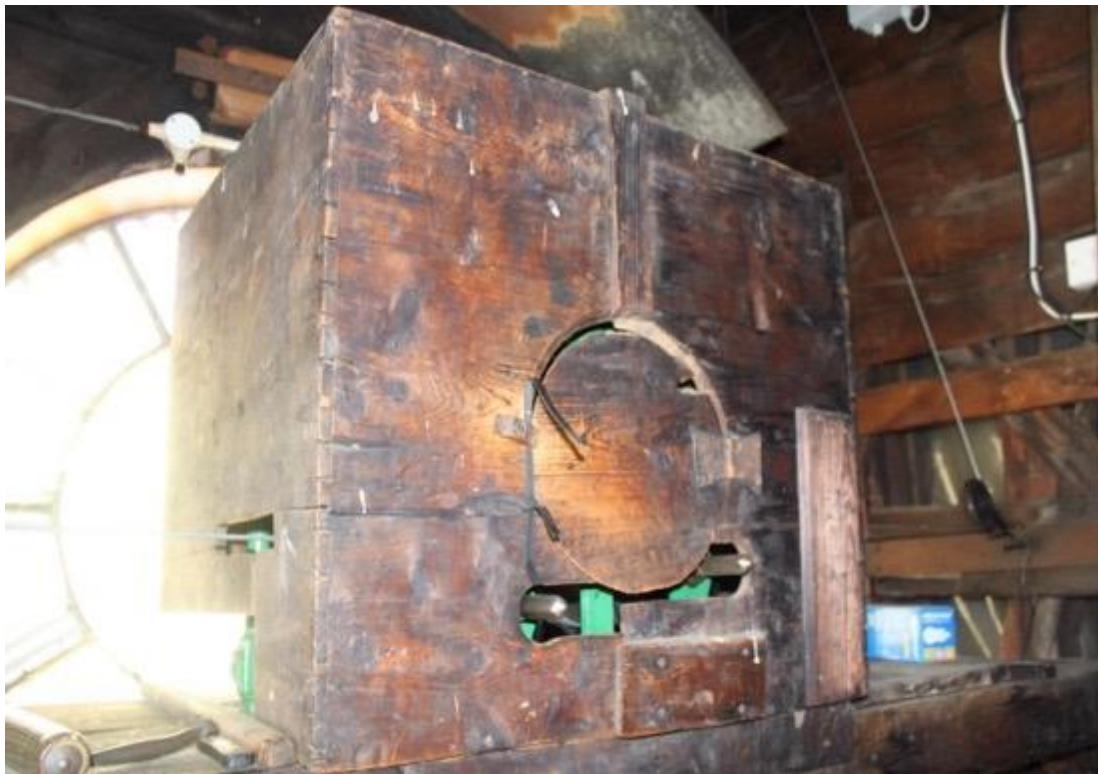
The hammer assembly to the bell has seized and the time keeping is reported to be poor. Repairs are needed.

It appears that the clock has not been regularly serviced. Clocks should be maintained annually.

The clock was inspected by the Cumbria Clock Company in July 2024 who offered various repair options including installing an automatic winding device.

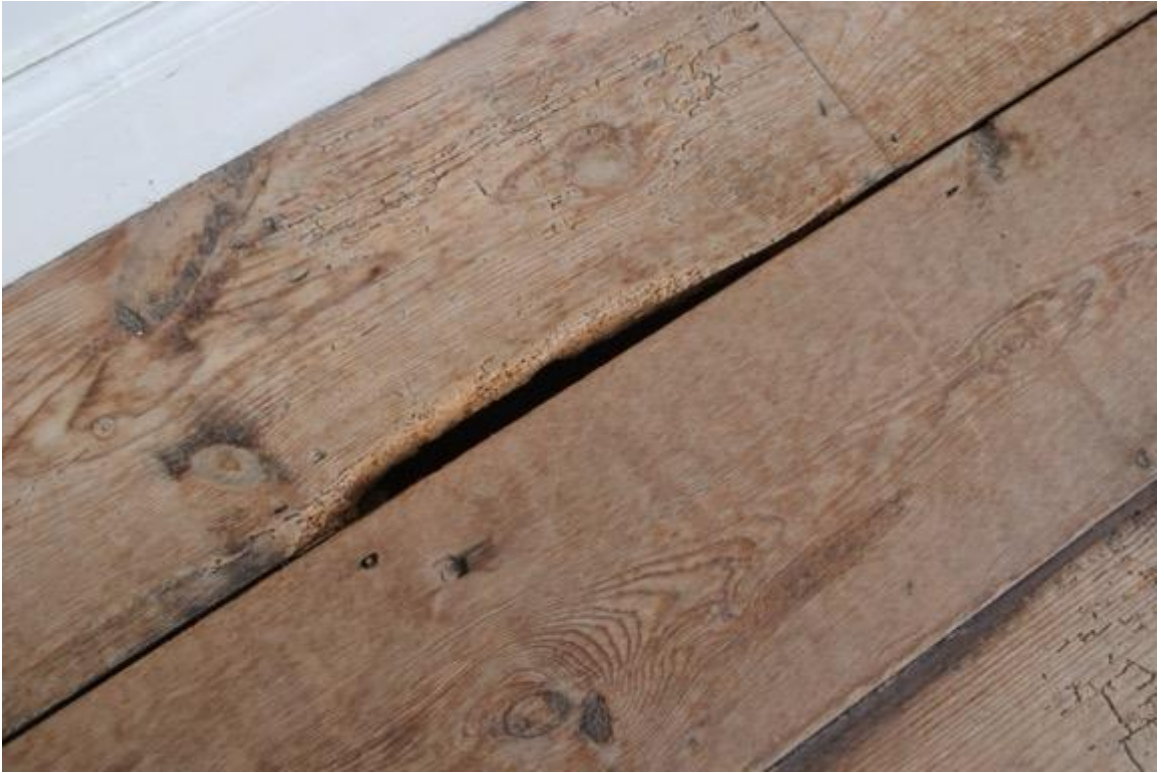
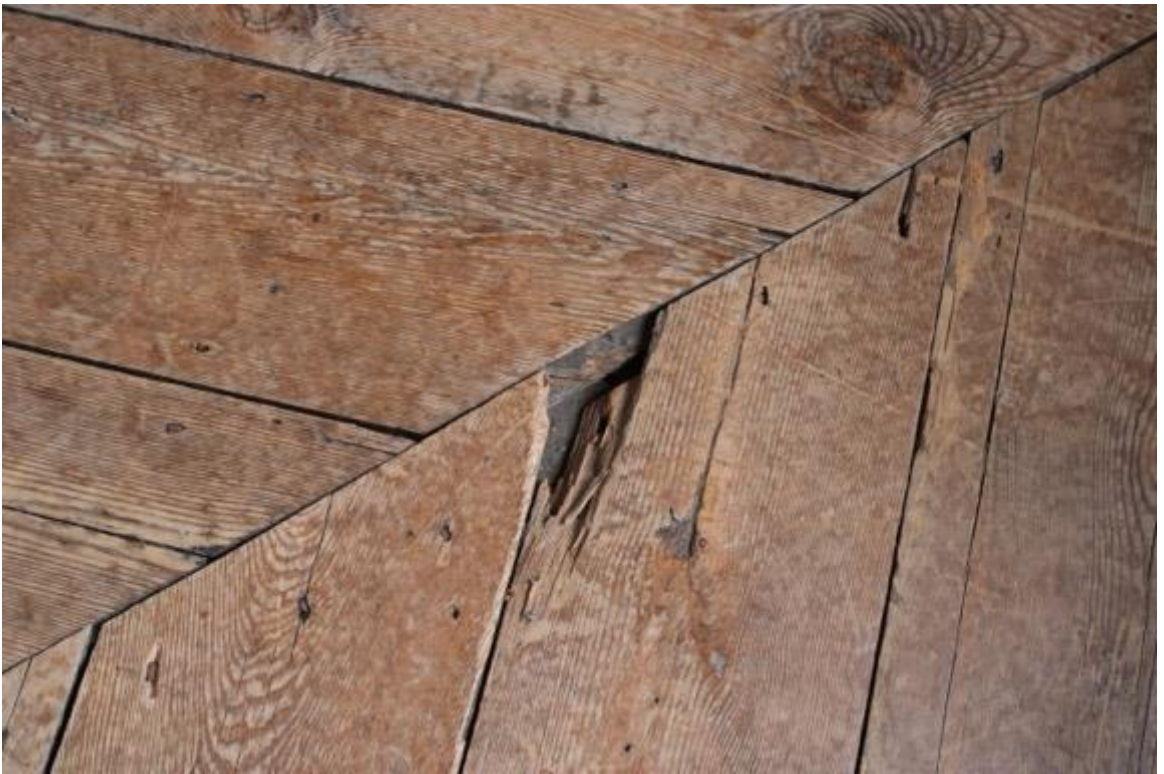
There are gaps between some boards and localised damage elsewhere that requires repair. The damage could constitute a trip hazard.

It would at the same time improve the appearance of the rooms to renew the finish to the boards. Samples should be undertaken using wax, stains and varnish before selecting a finish.

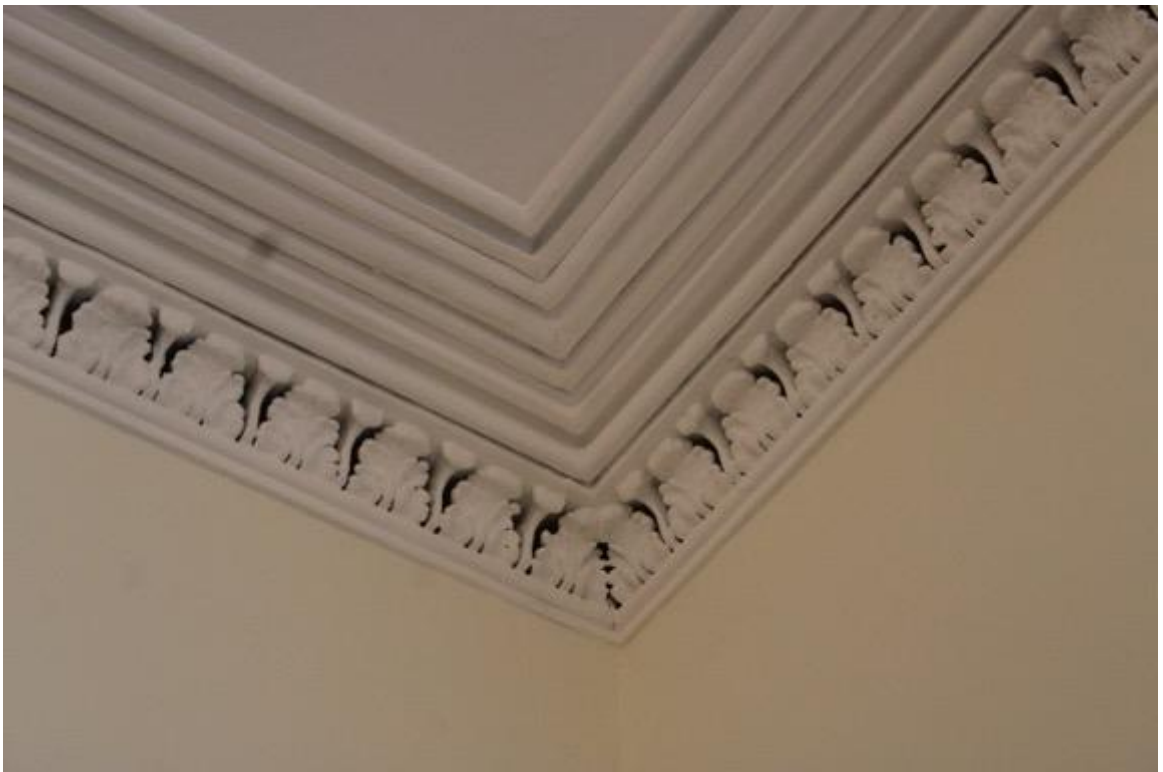
They are in generally satisfactory condition. Hairline cracking which is common on lath and plaster ceilings is minimal and unlikely to be of structural significance. The condition of the key between the plaster and timber laths should however be examined when access is made available into the roofspace.

The open crack running along the top edge of the cornice in the Committee Room is of greater concern. It may be related to a defect in the parapet gutter lining above. It should be periodically monitored and examined in greater detail when roofing works are undertaken.
