QUINQUENNIAL INSPECTION REPORT 2024

FAVERSHAM GILDHALL
MARKET PLACE FAVERSHAM
KENT ME13 7AG

DANIEL MARTIN *BSc, MA, MRICS*
CONSERVATION ACCREDITED CHARTERED SURVEYOR

Date of inspection December 2024

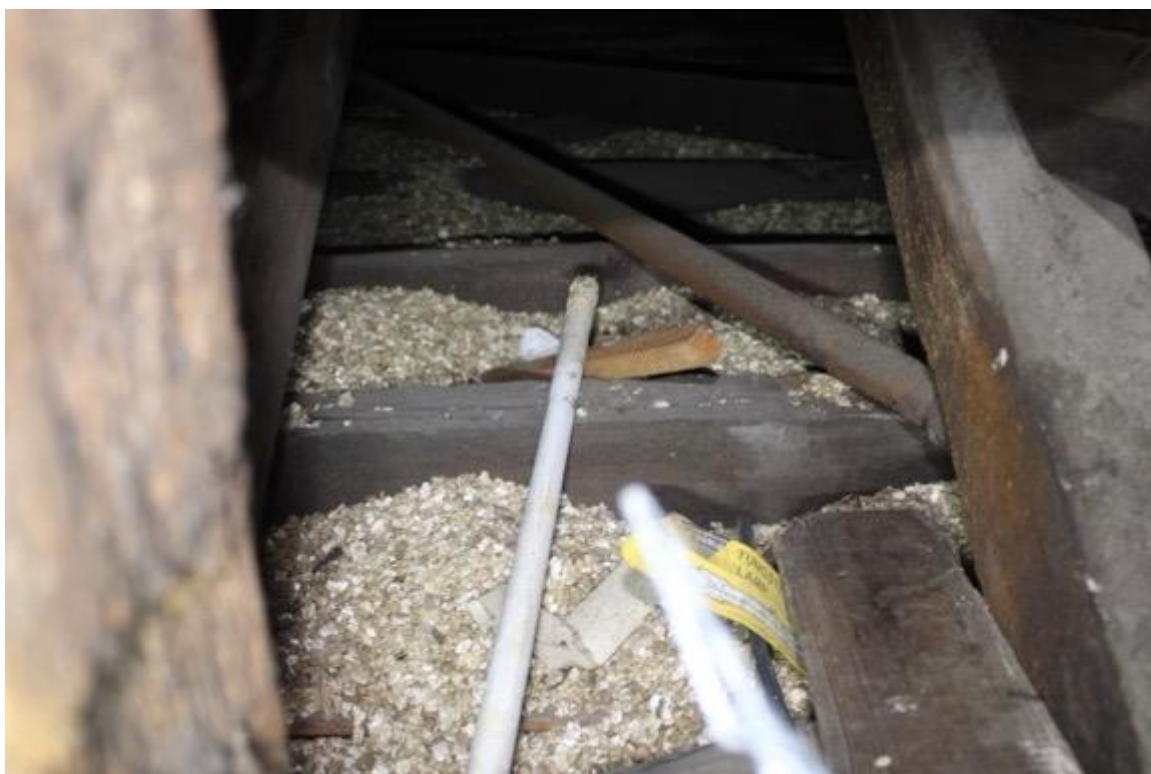
Vermiculate insulation is visible to the ceiling over the Committee Room. The thickness is insufficient to comply with current standards. More importantly some forms of vermiculite contain asbestos. It should be analysed in a laboratory and not be disturbed in the meantime.

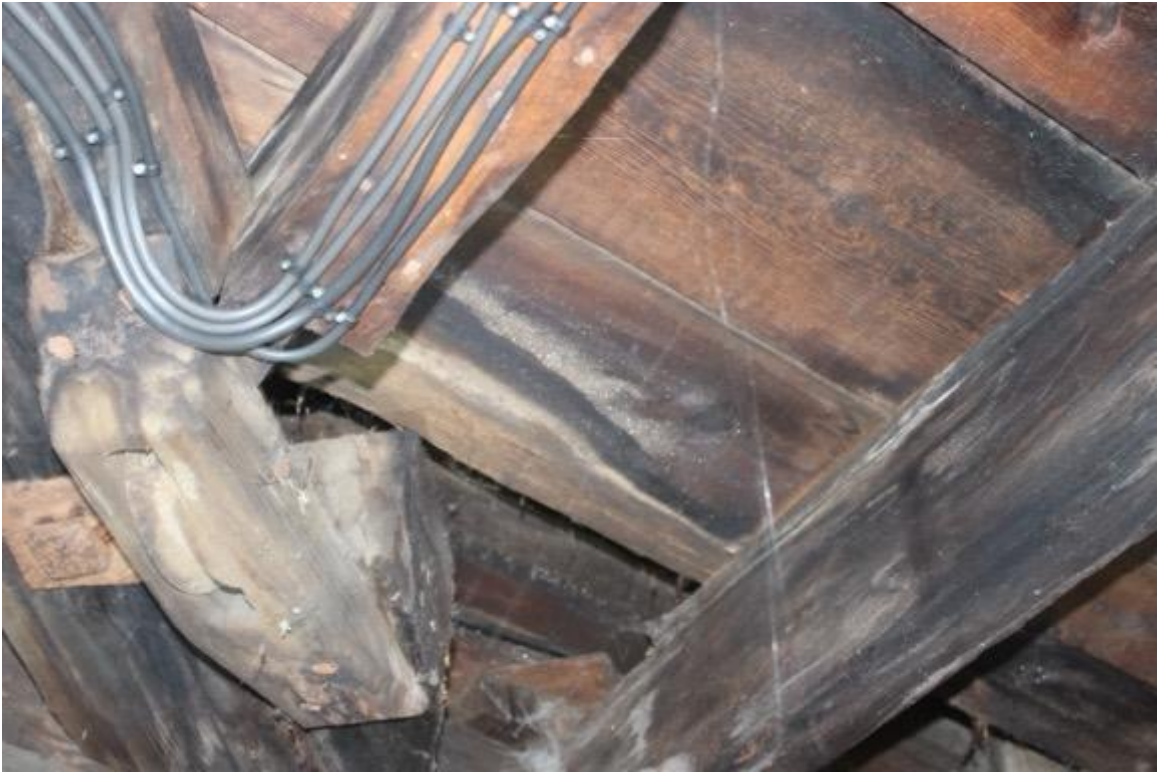
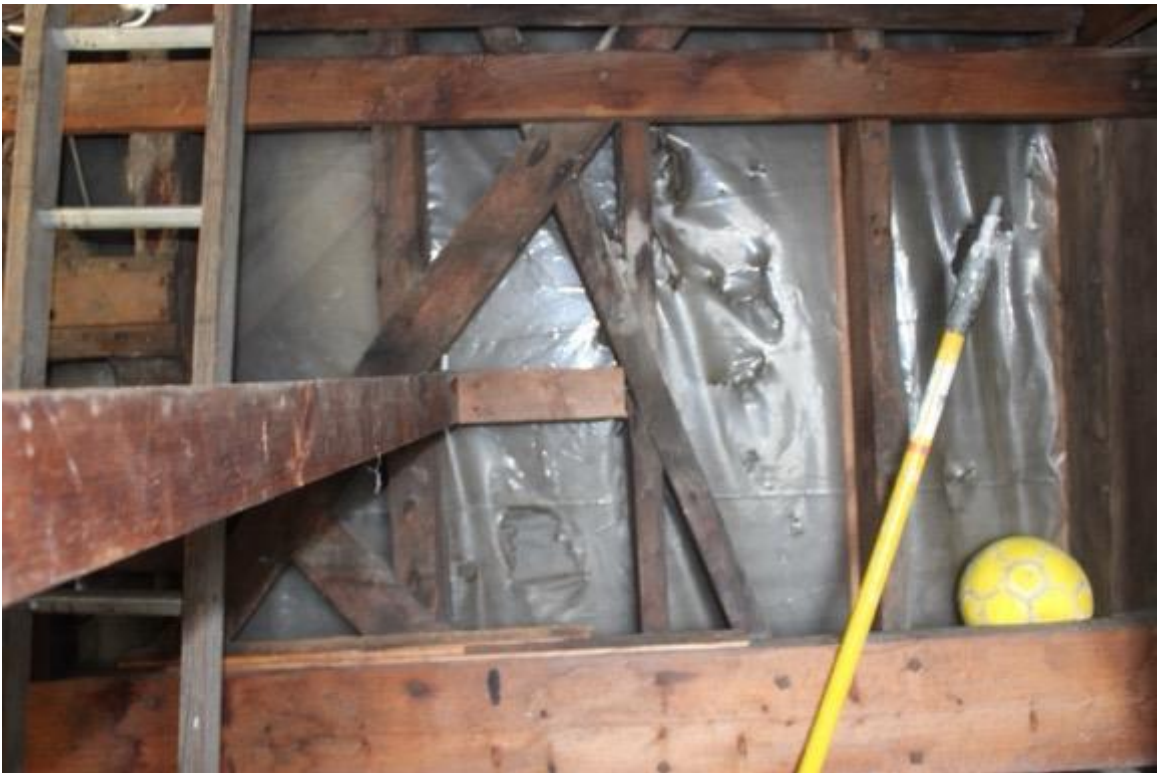
There is evidence of damp ingress to the timber boarded soffit of the roof.

The timber framed walls of the clocktower are lined with polythene. It is torn. This is a later addition possibly inserted to prevent water ingress. It is liable to trap moisture and should be removed.

An inspection of the roof to the tower and cupola is recommended using a mobile access platform that will also allow the dome to be inspected.

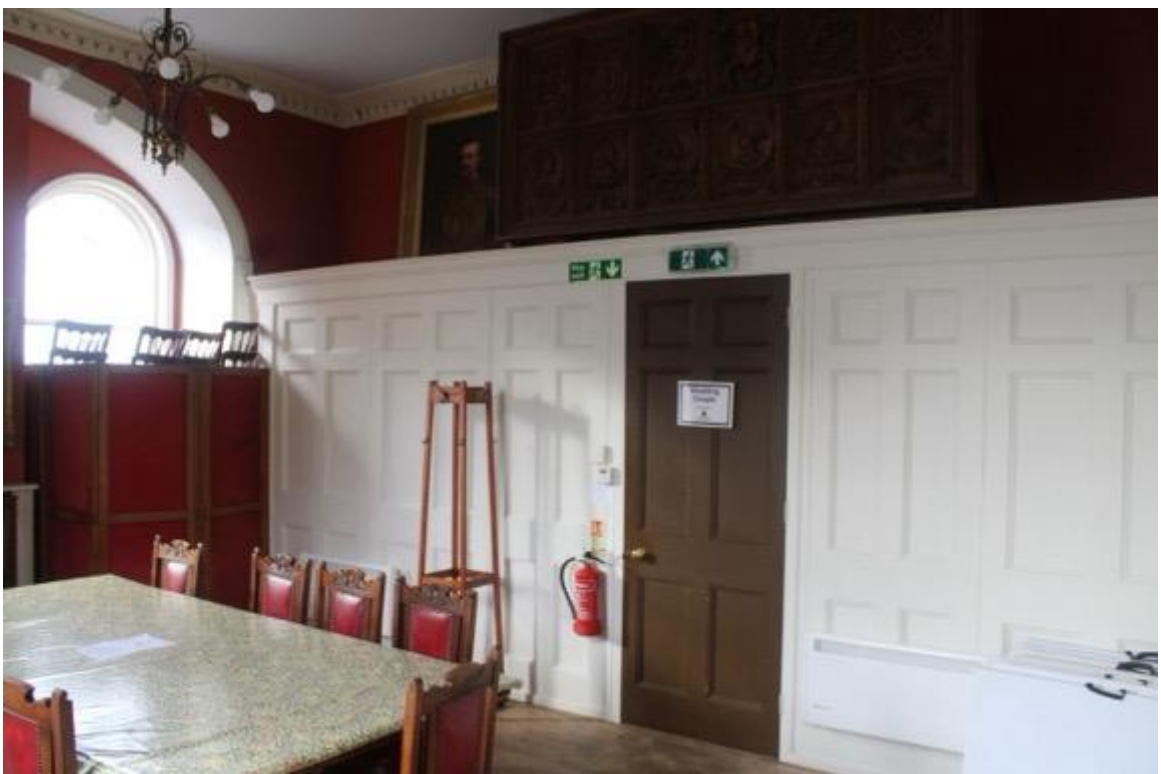
The plaster to the sides of the chimney breast in the Committee Room is hollow and unsound. It is liable to be contaminated with salts. Repair is not urgent.

There is dampness and unsound plaster to the walls of the entrance lobby. The arrangements for drainage to the paved areas surrounding this part of the building should be examined and the underground drains tested prior to considering inserting a damp proof course. Repair is not urgent.

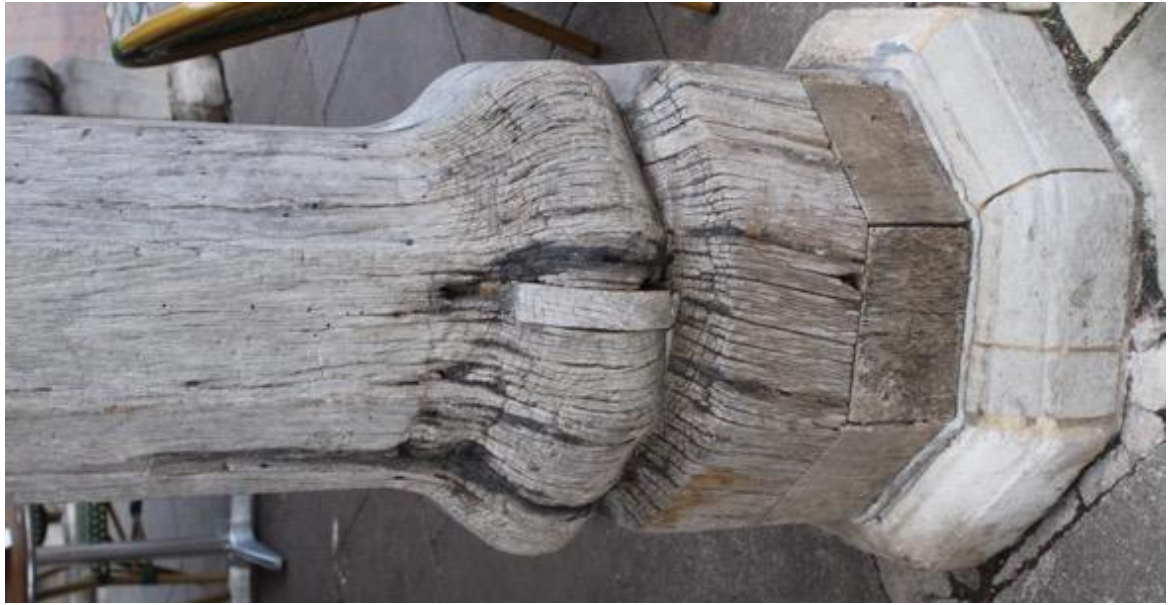
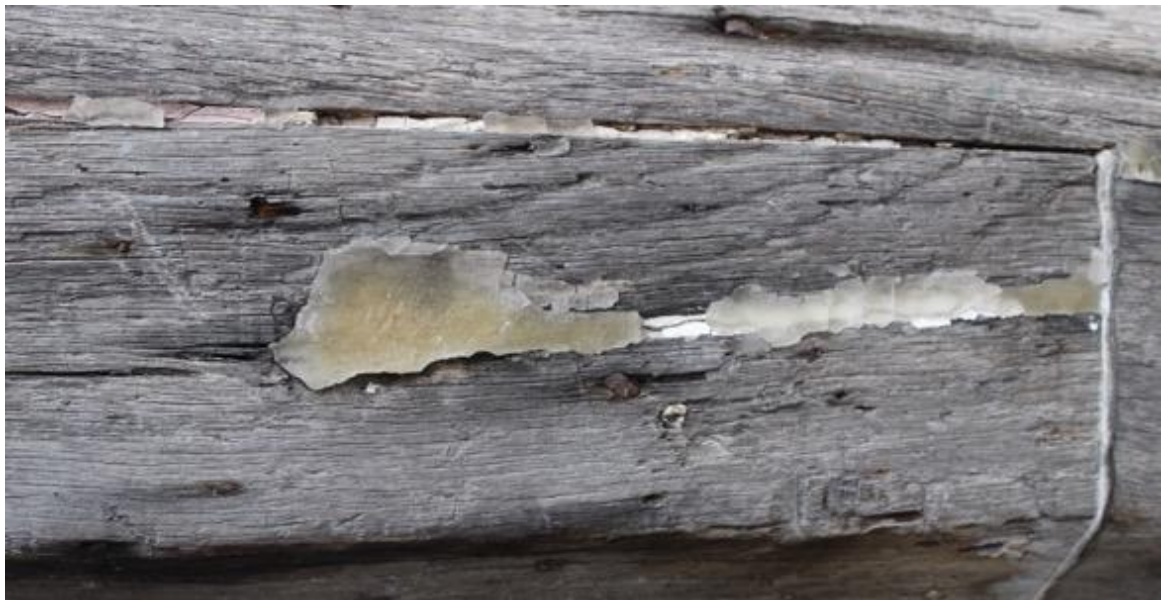
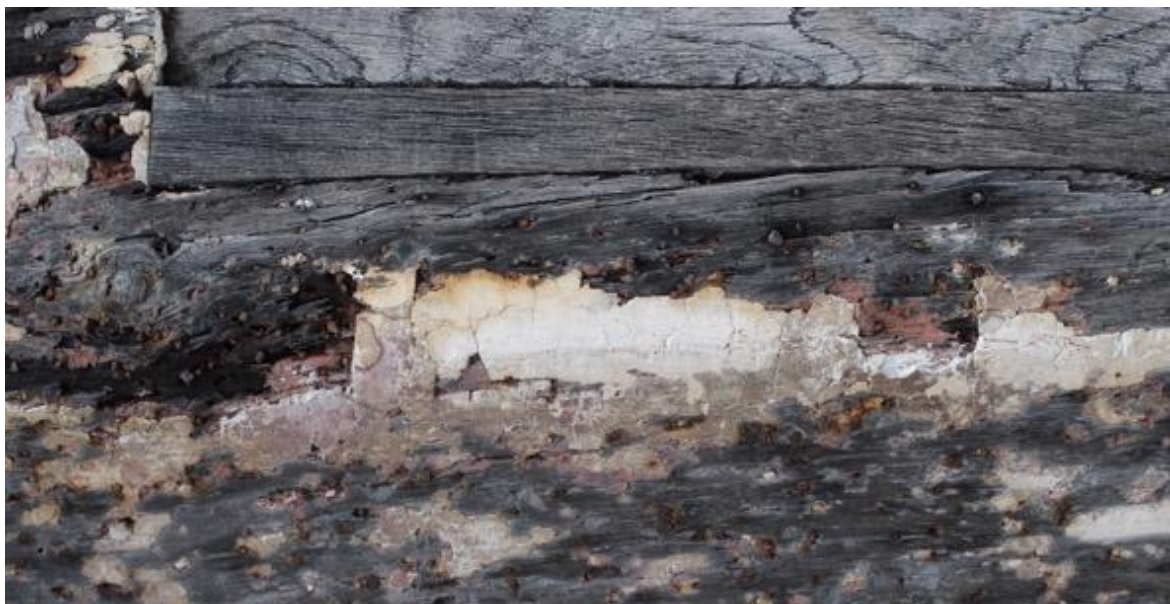
They have been repeatedly repaired using both inserted sections of oak and less successfully with filler and resins.

Oak of this age is extraordinarily strong and durable and a few cracks and fissures are unlikely to affect its performance.

The resins and fillers will however trap moisture and will advance decay. They should be removed.

A detailed survey of each column should then be undertaken.

Repairs are likely to be relatively small and localised. Resins might be used but need to be very carefully controlled and preceded by trials. The preference should however be to piece in replacement timber cut and shaped to each specific defect.

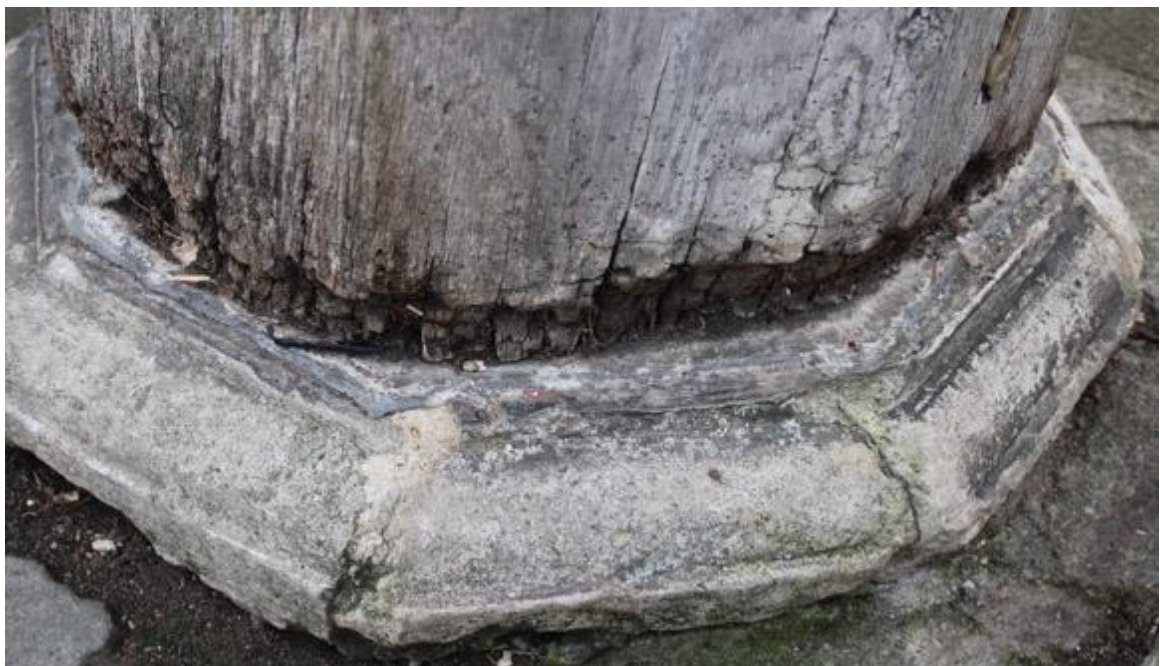
The height of the plinths varies as the ground slopes. The type of stone also varies suggesting some of the plinths are replacements.

The stonework is in average condition. Some open joints and cracks require repointing but repairs will be localised and minor. All repairs should use lime-based mortar mixes.

Where there is excessive decay to the base of the column the DPC should be checked.

The fill between the stone plinth and pavings often needs repair.

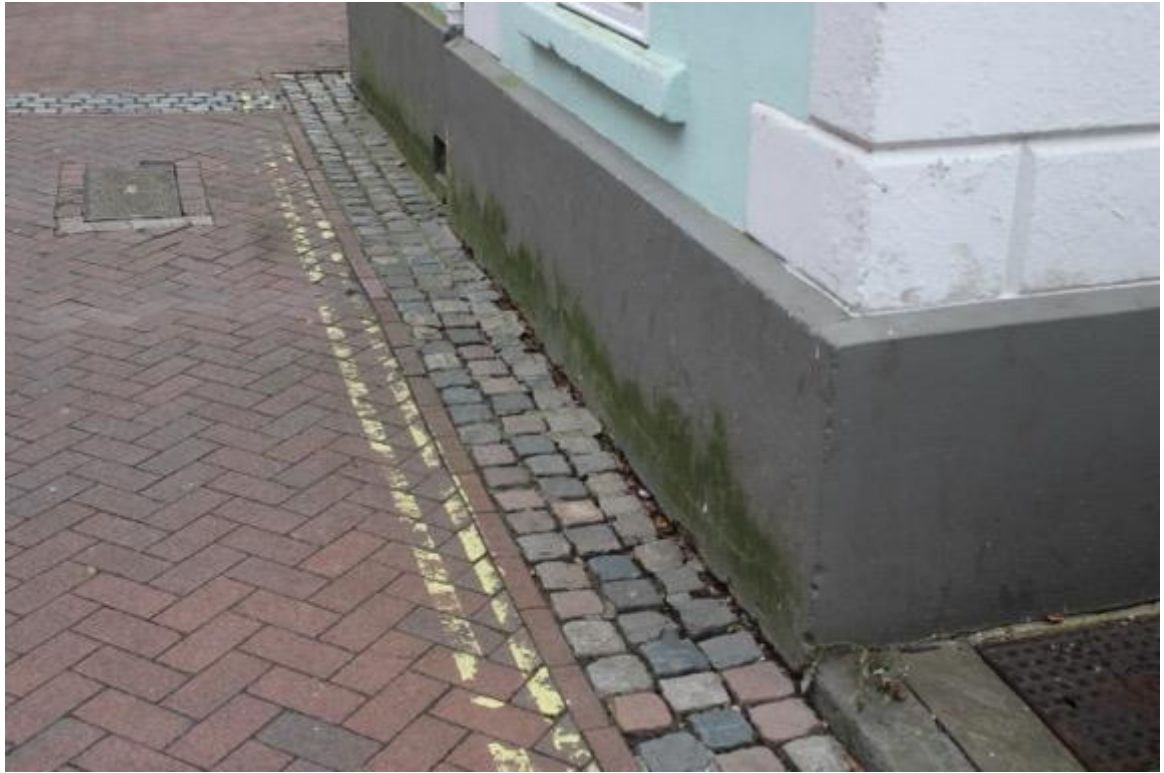
There are large number of cracked concrete pavings and much smaller number of damaged Yorkstone slabs which need to be replaced. Greater care needs to be exercised in policing the use of the area by market traders to prevent future damage.

The granite setts to the perimeter of the pavings need local repointing. Those to the base of the tower should be prioritised as their condition may be a cause of the internal dampness found in this part of the property.
