**REPORT ON CONDITION
FAVERSHAM CREEK OLD PUMPING STATION HOUSE
KENT ME13 7DF**

DANIEL MARTIN

RICS CERTIFIED HISTORIC PROPERTY PROFESSIONAL

Date of Survey 25 July 2025

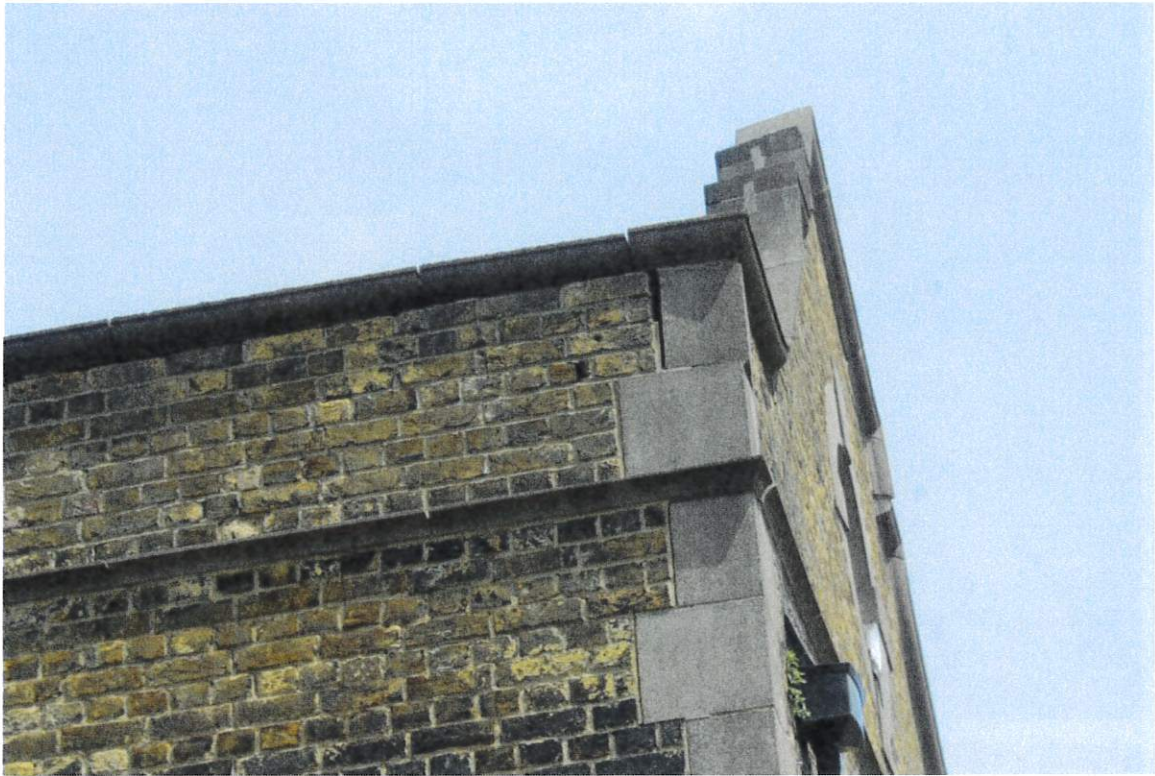
The external walls appear to be structurally sound other than the movement to the front elevation gable which has been examined in the previously reference structural engineers report. The parapet has moved outwards in the southeast corner of the building and the uppermost quoin and copings above have twisted out of position with wide open joints between adjacent blocks of stone.

Structural movement to southeast gable.

The engineer has recommended tying back the gable wall to the roof structure using metal straps to counter a lack of lateral restraint. Once this has been done the open joints between copings and quoins should be repointed. It may also be necessary to remove and reset some of the stones. Lime mortar should be used to bed and repoint the blocks.

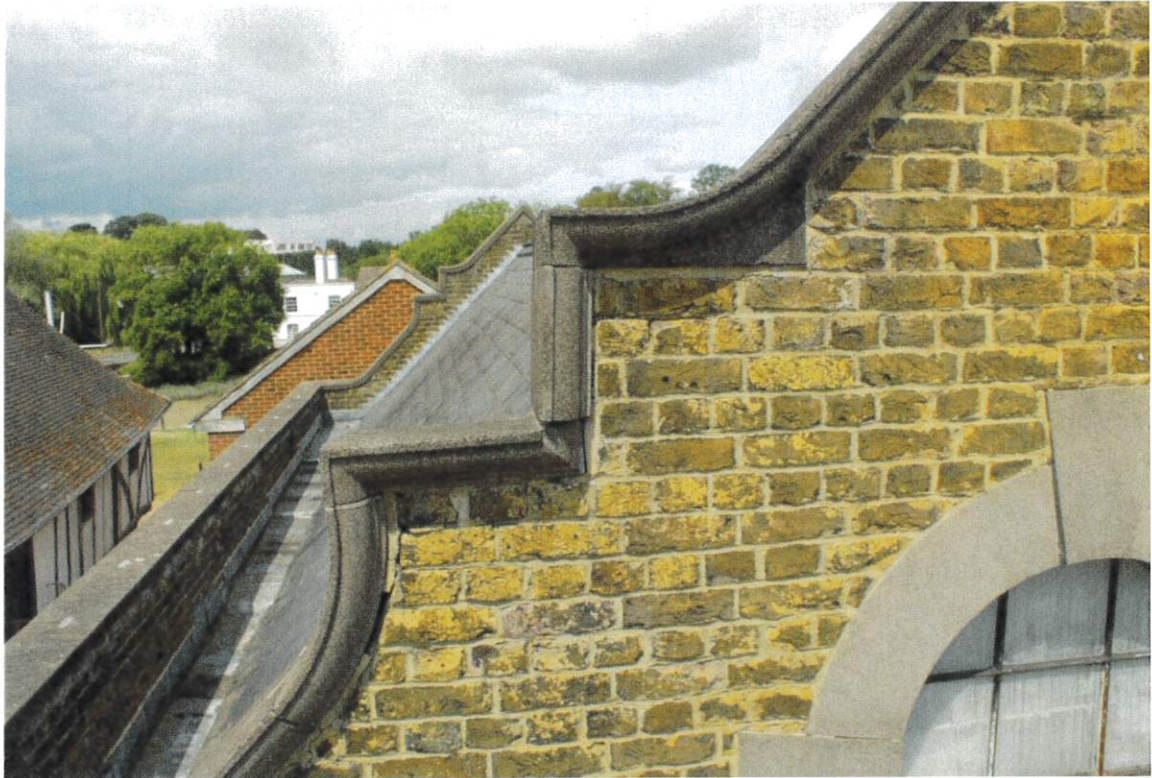
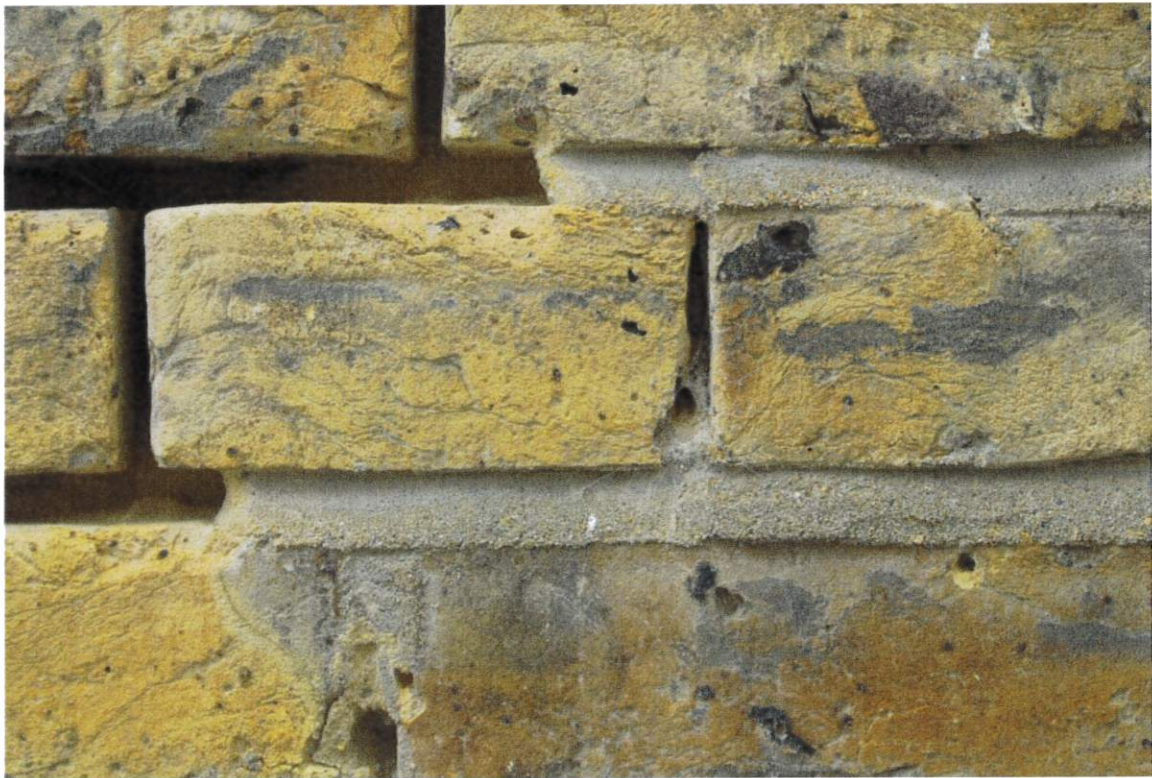
It is understood that the Creek commonly floods leaving the base of the building surrounded by sea water. The salts contained in the water will be retained in the walls and as the flood recedes the salts will crystallise especially within the zone of evaporation which will be slightly higher up the wall. The process of crystallisation will cause the pointing to fail. The extent of failure will be affected by the type of mortar used in the brick joints. It can be seen in places that cement mortar used for repointing the walls has trapped moisture and caused erosion to occur deeper into the joint. The pattern of failure will also be influenced by the ground level surrounding the building which varies by about 500mm. In some areas the flood water will take longer to subside and the problem will be more severe.

The bricks have survived reasonably well and the damage is almost entirely to the pointing. This in many respects is good news. The mortar should always be seen as sacrificial in brick walling.

Erosion behind cement mortar pointing.

Whilst the flooding continues it will be difficult to prevent future damage occurring. Improvements to the land drainage and landscaping surrounding the building would however be beneficial. Repointing will need to be accepted as an ongoing task as the salts now present will be very difficult if not impossible to remove. The mortar used should be lime based and sacrificial. Consideration might also be given to removing the internal render or replacing it in breathable lime plaster.

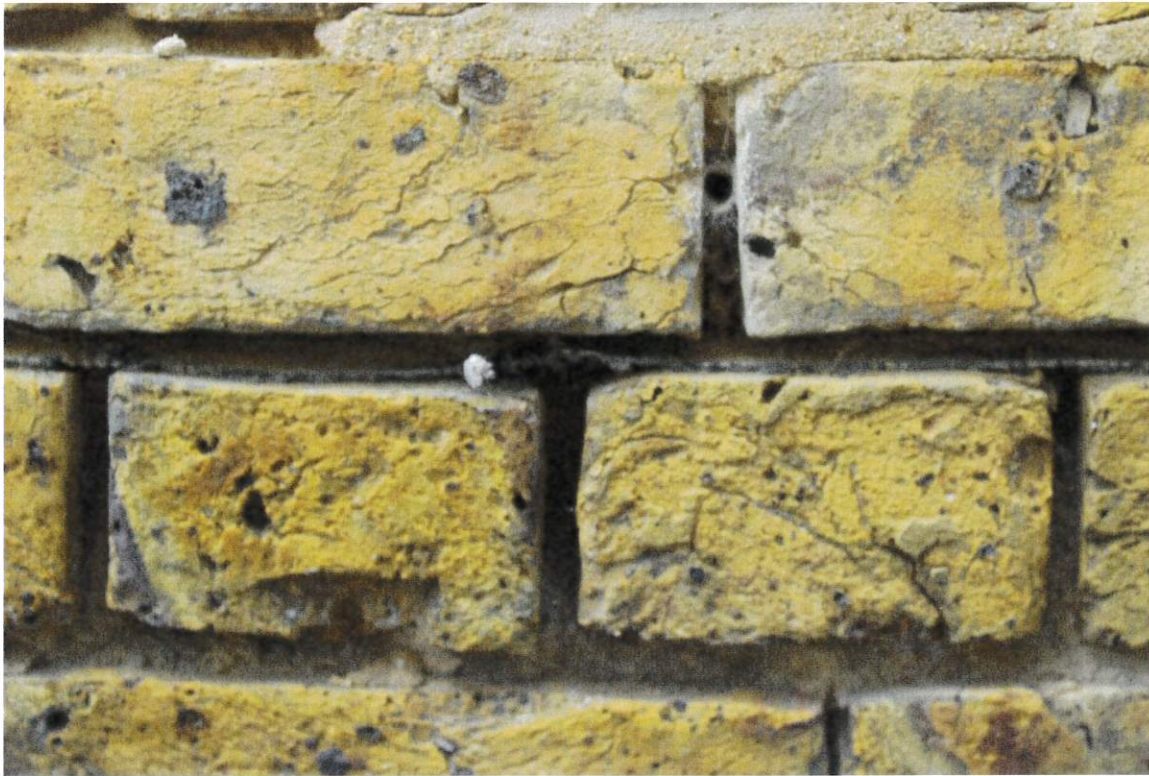
The form of the floor may also be a contributing factor. It is of solid concrete construction and will as the walls be subject to moisture movements if the site is subject to repeated flooding. If there is a DPM in the floor and it is not properly linked to the DPC in the walls this will provide another pathway for the escape of moisture, evaporation and salt crystallisation.

Bitumen DPC in flank walls. Is this linked to a DPM in the floor?

Before any remedial action is taken it will be important to verify the above hypothesis by further investigations which should include analysis of the mortar for salts, determining the nature of the internal render and localised opening up of the floor to check the link between the membranes in the floor and walls.

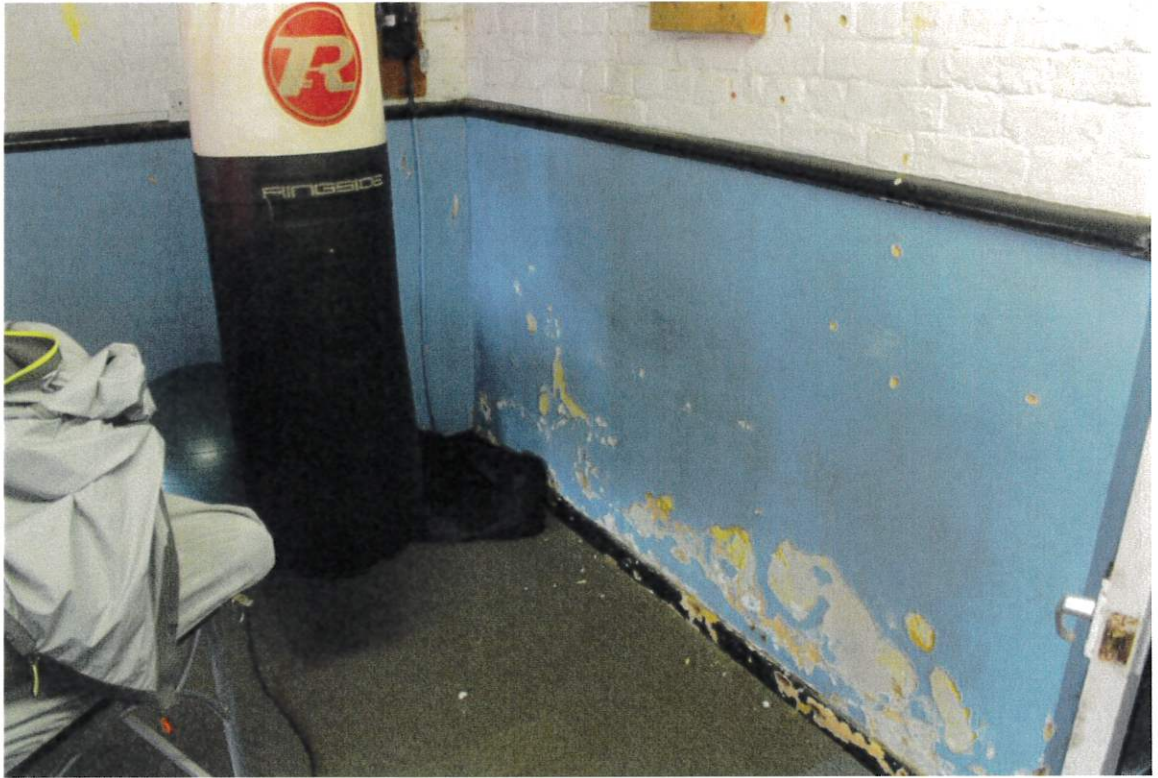
Inside the building the base of walls are finished with a render coat to dado level above which the brickwork is exposed and painted. The render is likely to limit evaporation from the inner wall face and increase the damage to the visible exterior.

Moisture readings taken inside the building found that the highest levels of dampness were within the render which conforms this supposition.

Rendered internal dado.
