QUINQUENNIAL INSPECTION REPORT 2024

FAVERSHAM GILDHALL
MARKET PLACE FAVERSHAM
KENT ME13 7AG

DANIEL MARTIN *BSc, MA, MRICS*
CONSERVATION ACCREDITED CHARTERED SURVEYOR

Date of inspection December 2024

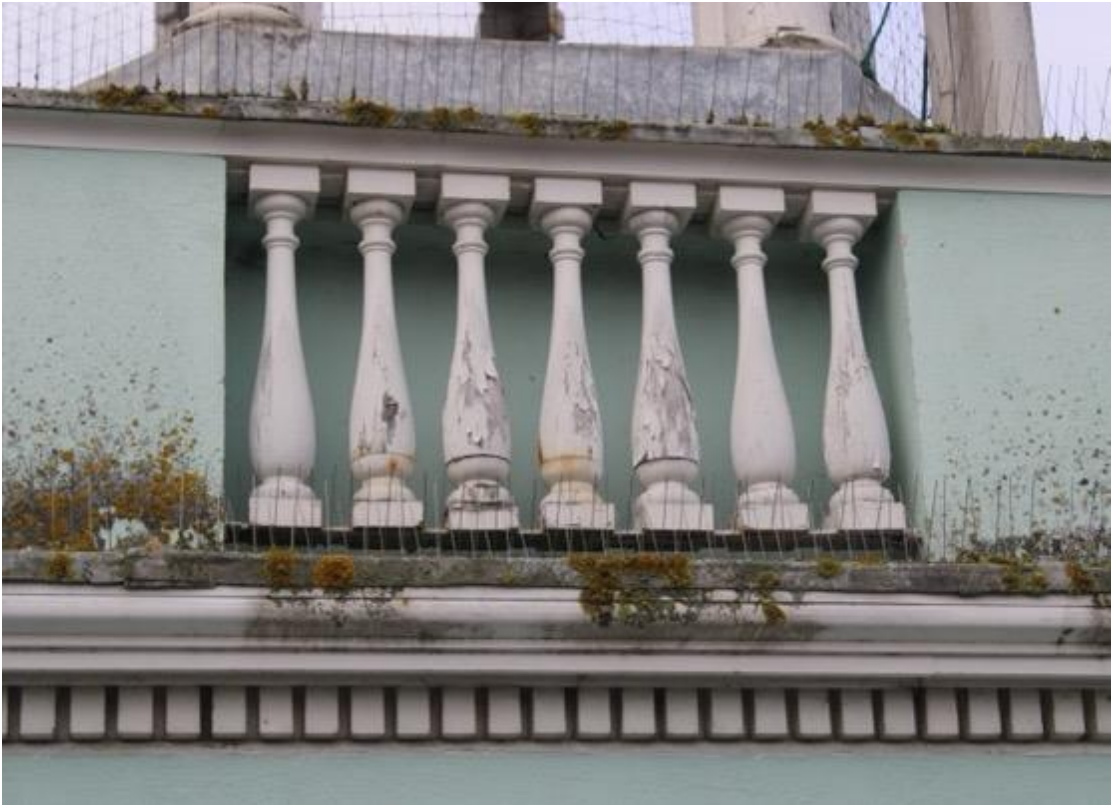
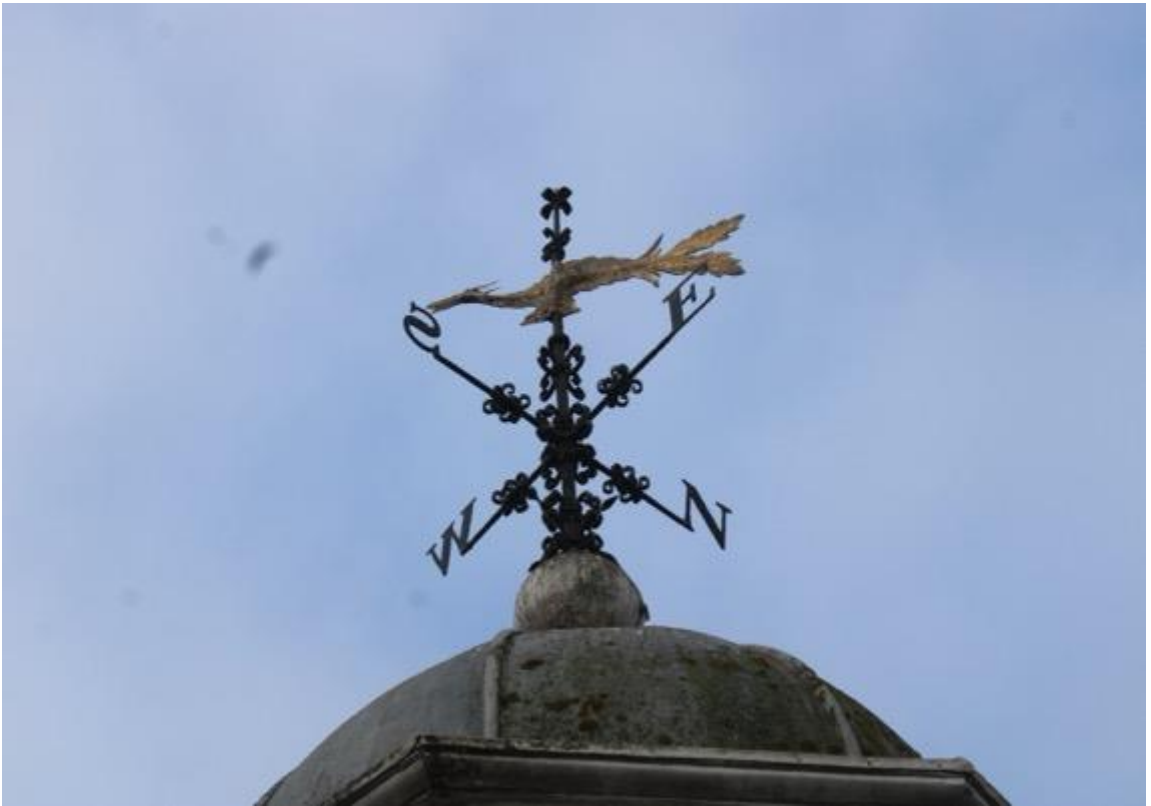
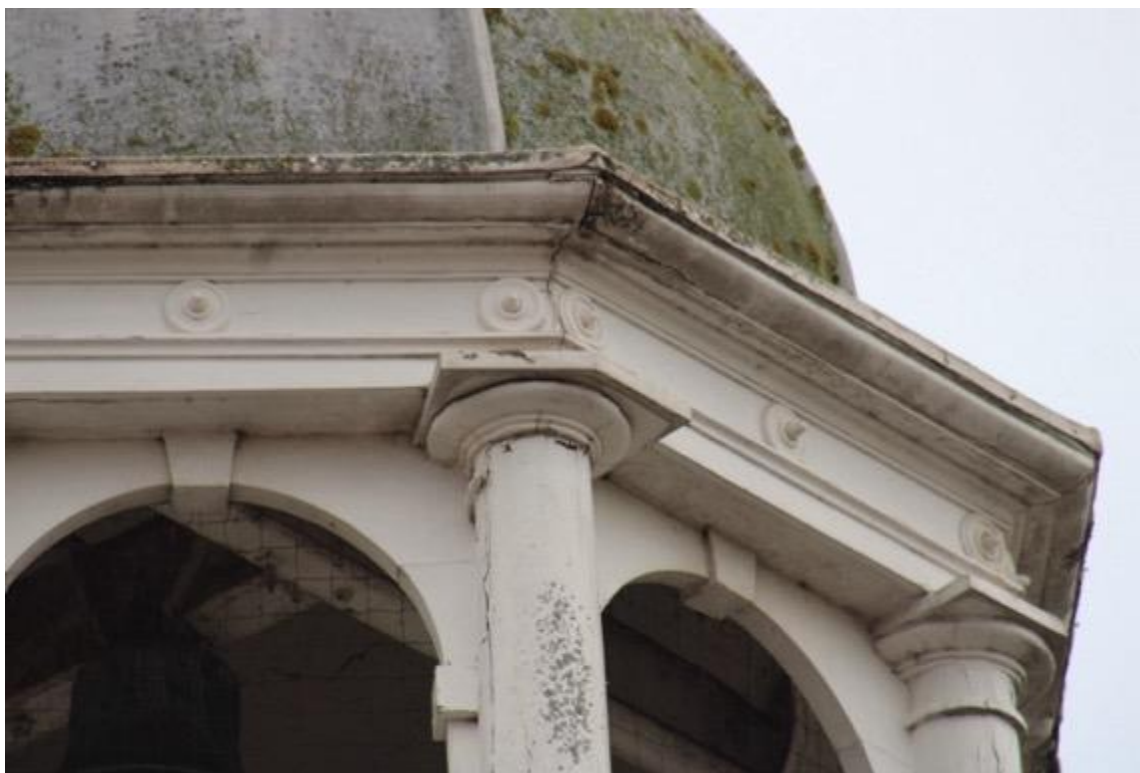
2.1.2 Clock Tower Roof and Cupola **In poor condition: further investigation needed.**

There is evidence of decay to all parts of exposed timber framework but a closer inspection is needed to quantify the extent of deterioration.

At this stage it is felt that the repairs are likely to be localised but extensive. There is evidence to suggest that earlier repairs have been carried out and the failures are occurring at the interface between the original and new wood. The choice of wood for carrying out the work is crucial to the long-term survival of pieced in timber repairs.

A lead lined gutter appears to run around the perimeter of the dome above the ring beam. The structure immediately beneath this gutter will be especially vulnerable to decay. The arrangements for disposal of the water collecting in the gutter are unclear. The outlet is likely to be blocked.

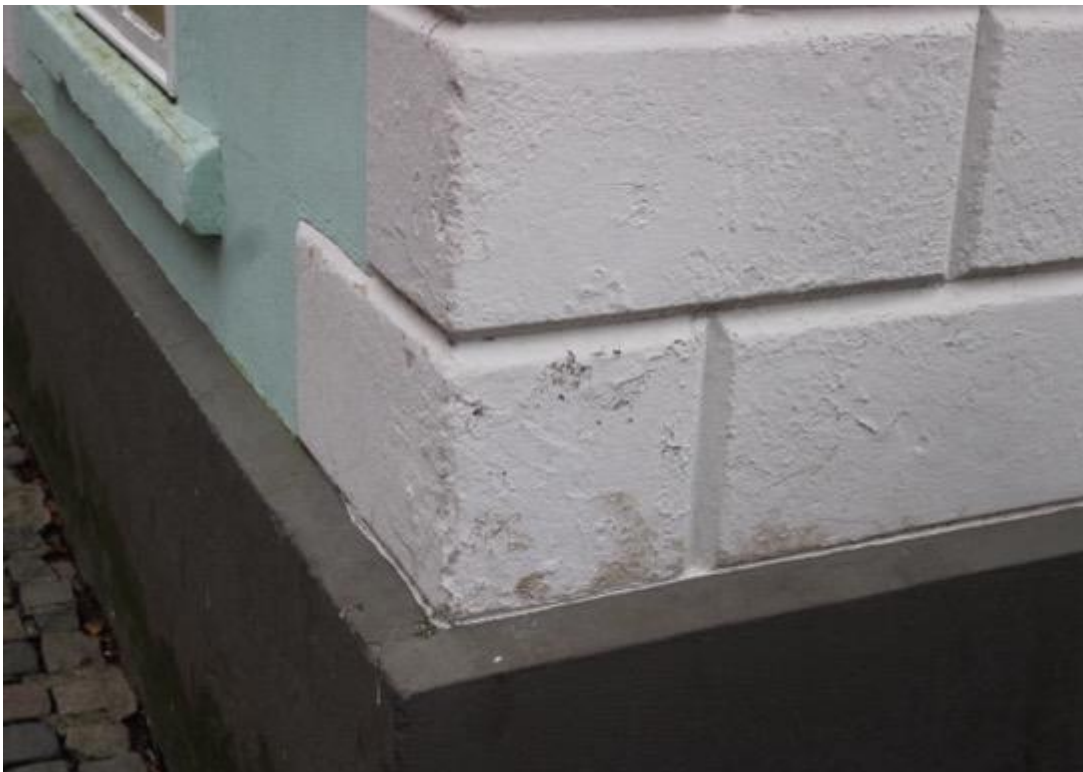
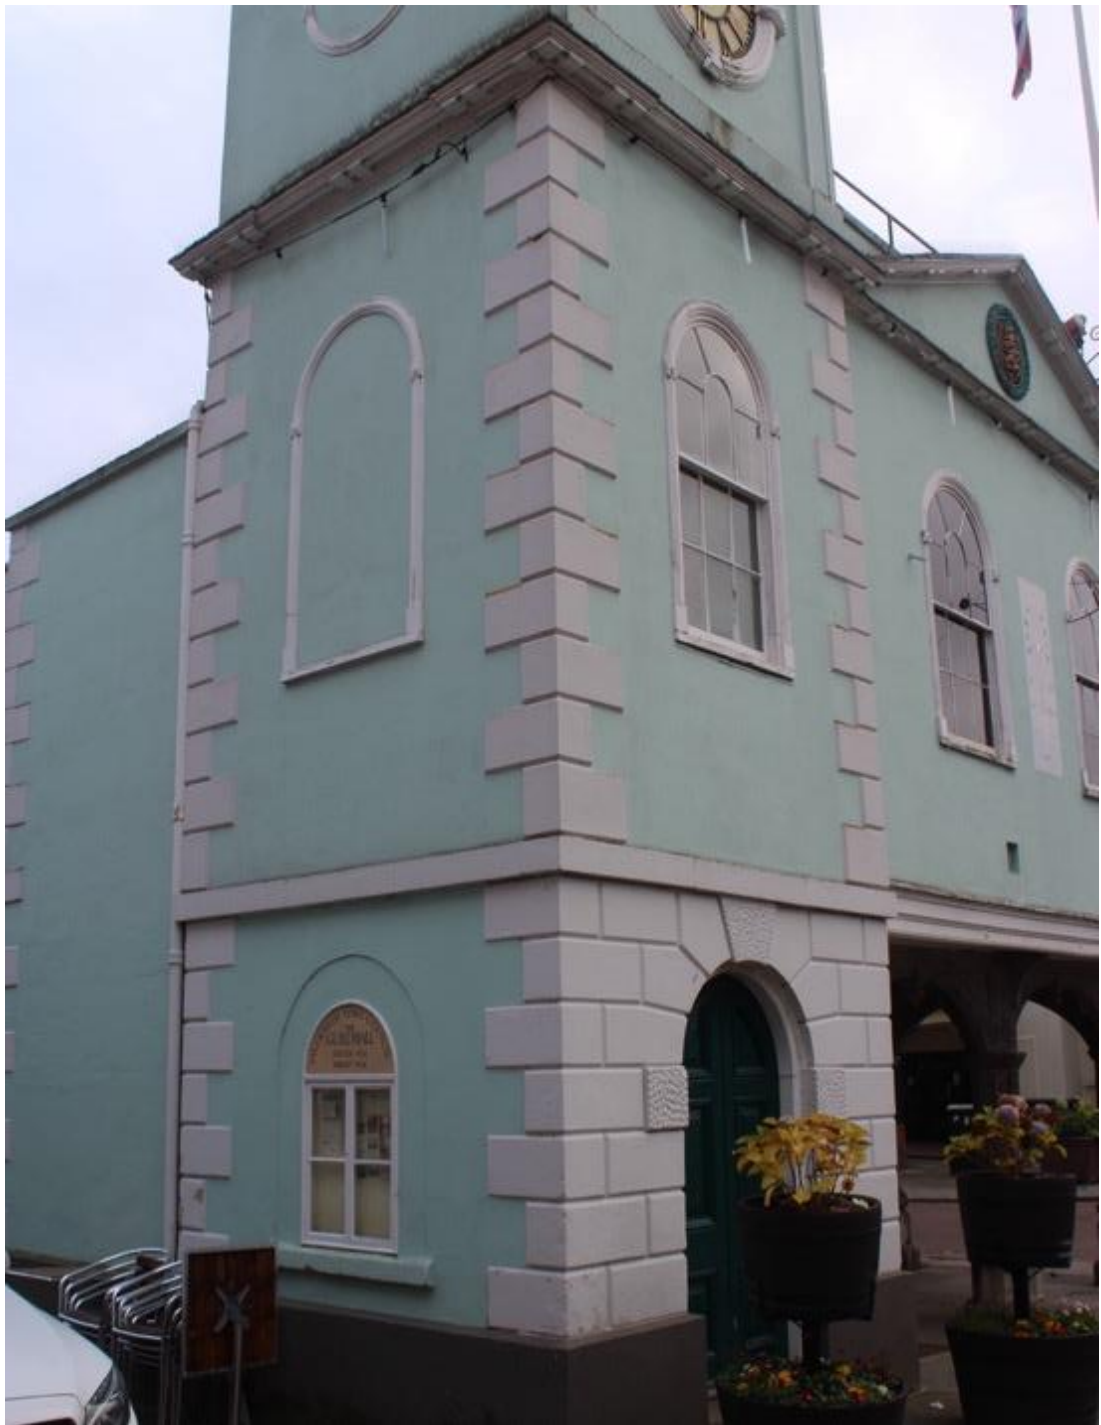
2.3.2 Clock Tower **In satisfactory condition**

There are raised quoins at each corner and full rustication to the main entrance door surrounds. A simple black painted plinth sits at its base.

The timber cornice from the main building continues at second floor level with a simplified plain band at first floor level.

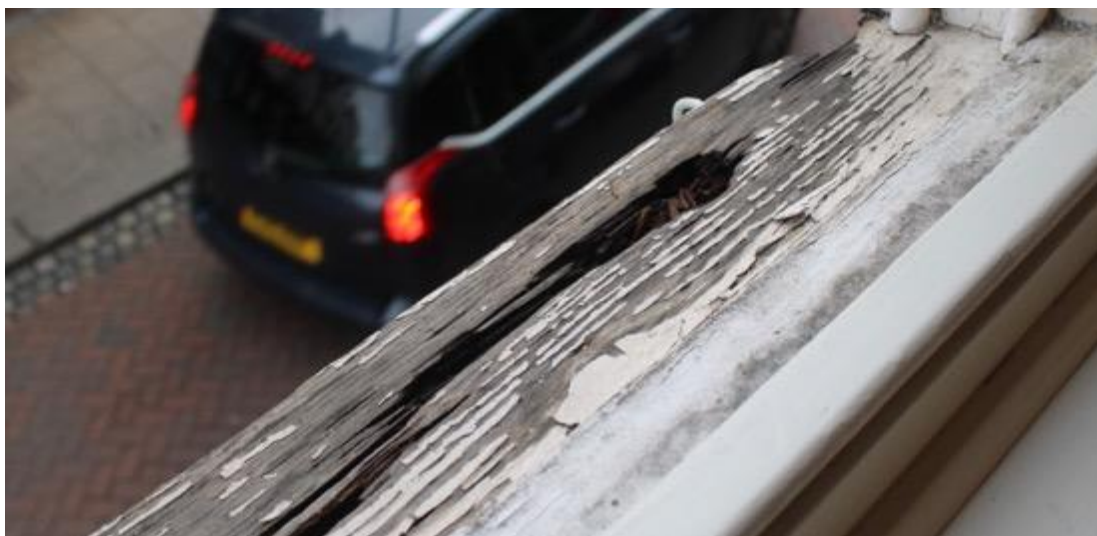
Widespread previous repairs and limited localised decay. Timber for replacement repairs should be carefully selected and carried out by carpenter/joiner rather than a painter/decorator.

Many sashes are replacements but are well matched to the original details.

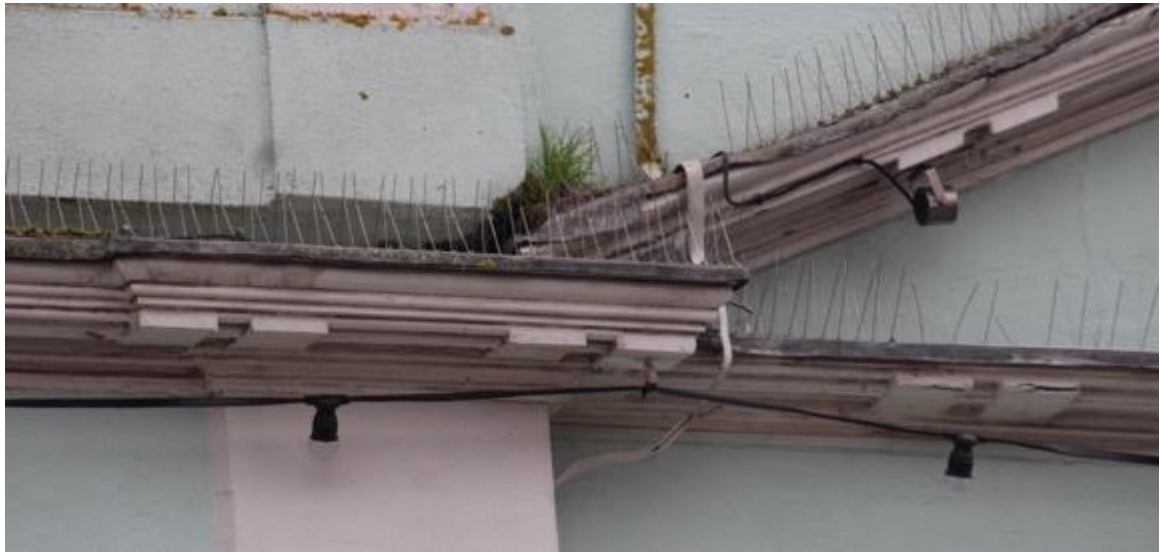
The lead coverings need redressing, and some lengths may require replacement. Improved clipping to exposed edges may be needed.

Consideration should be given to removing the unsightly plastic bird spikes. They are better methods available if bird control is deemed necessary.

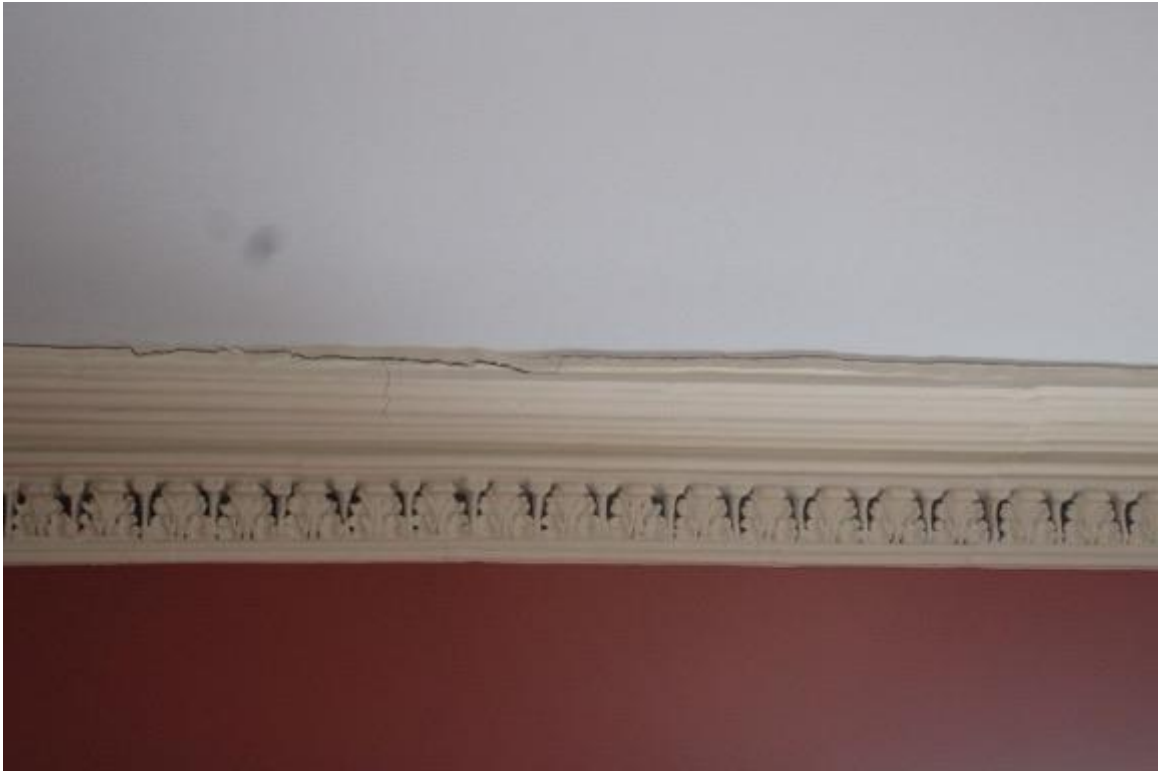
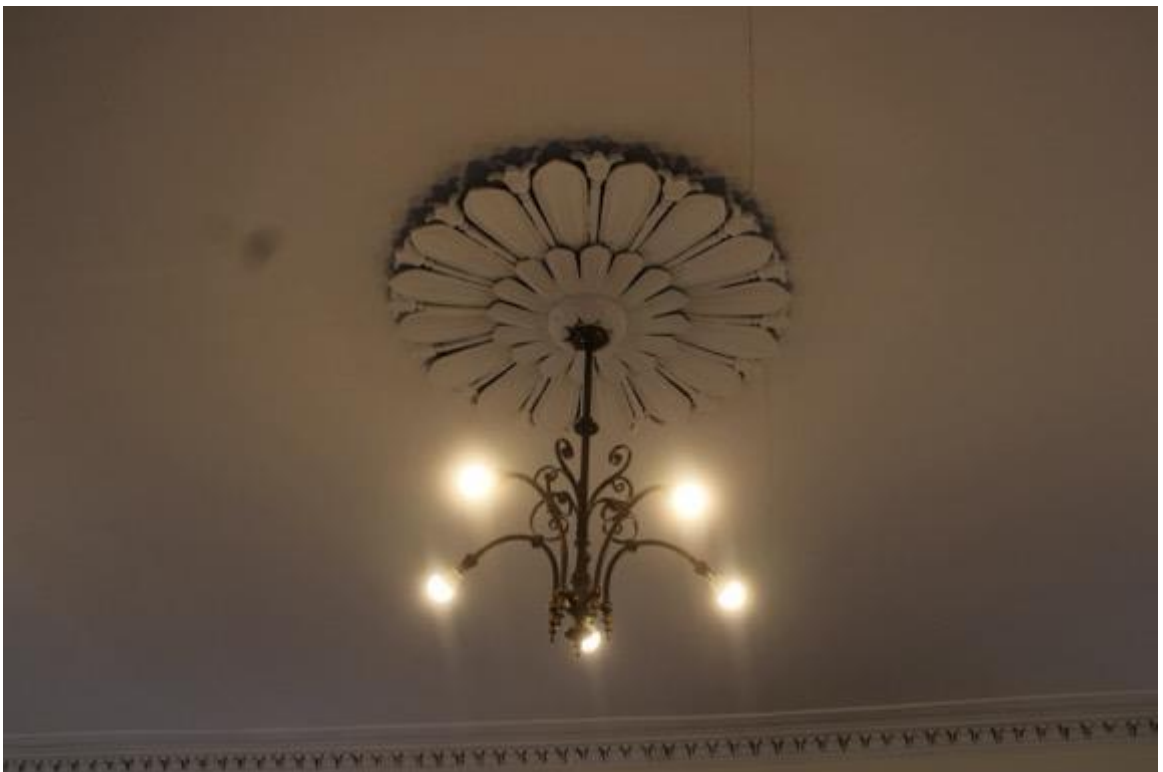
Vermiculate insulation is visible to the ceiling over the Committee Room. The thickness is insufficient to comply with current standards. More importantly some forms of vermiculite contain asbestos. It should be analysed in a laboratory and not be disturbed in the meantime.

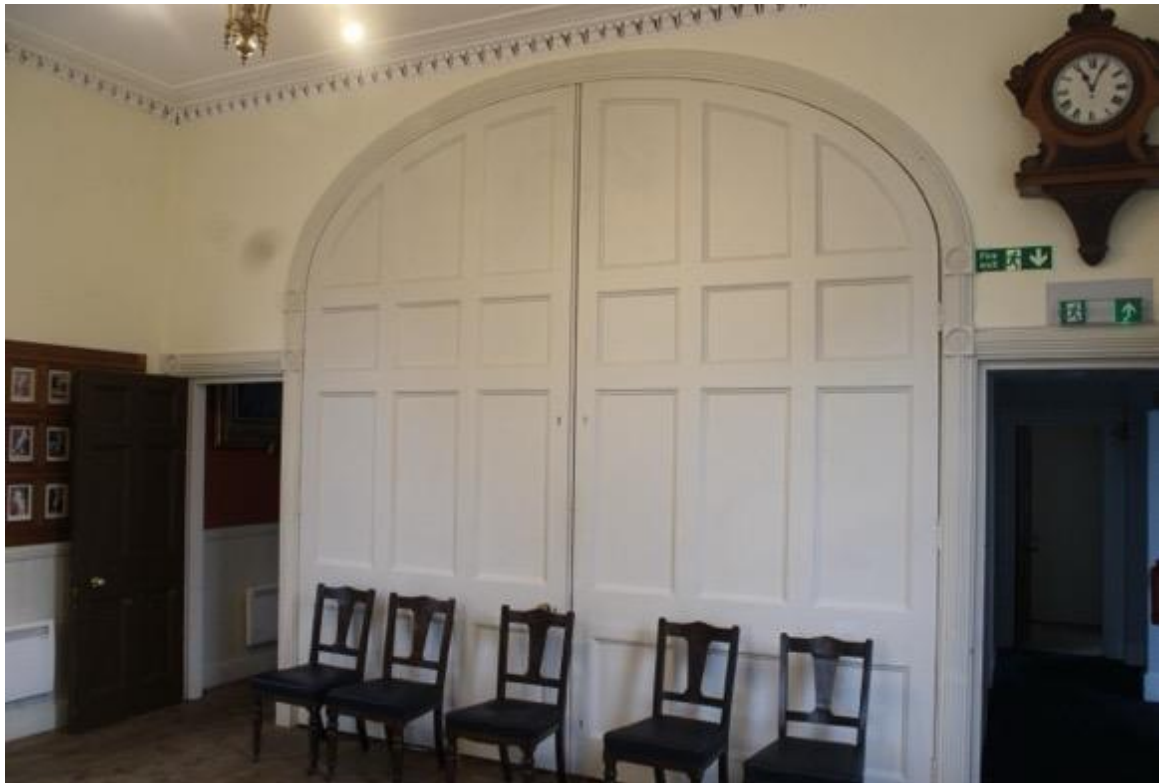
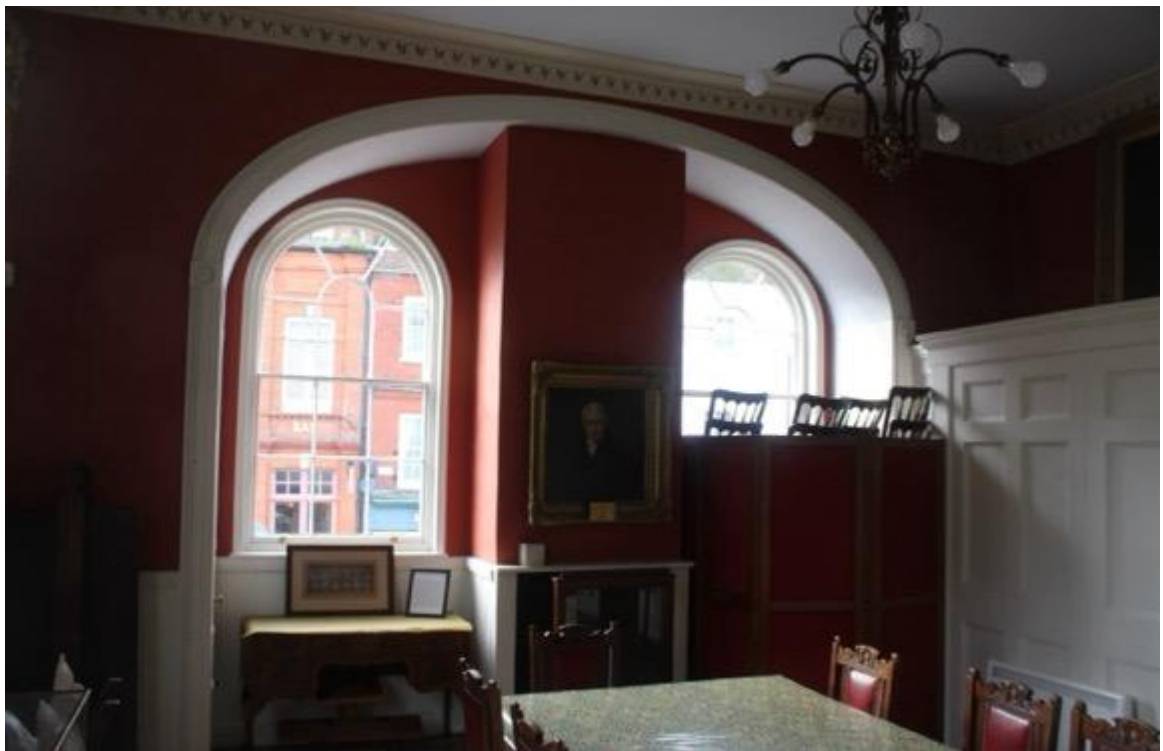
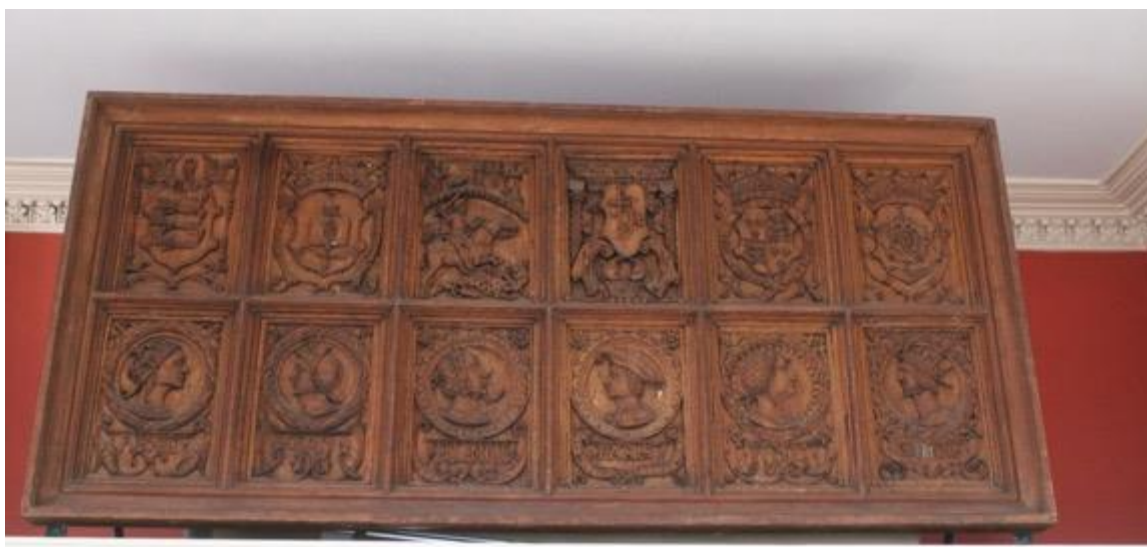
Duplicate of fire signs should be removed.

The main entrance door needs easing.

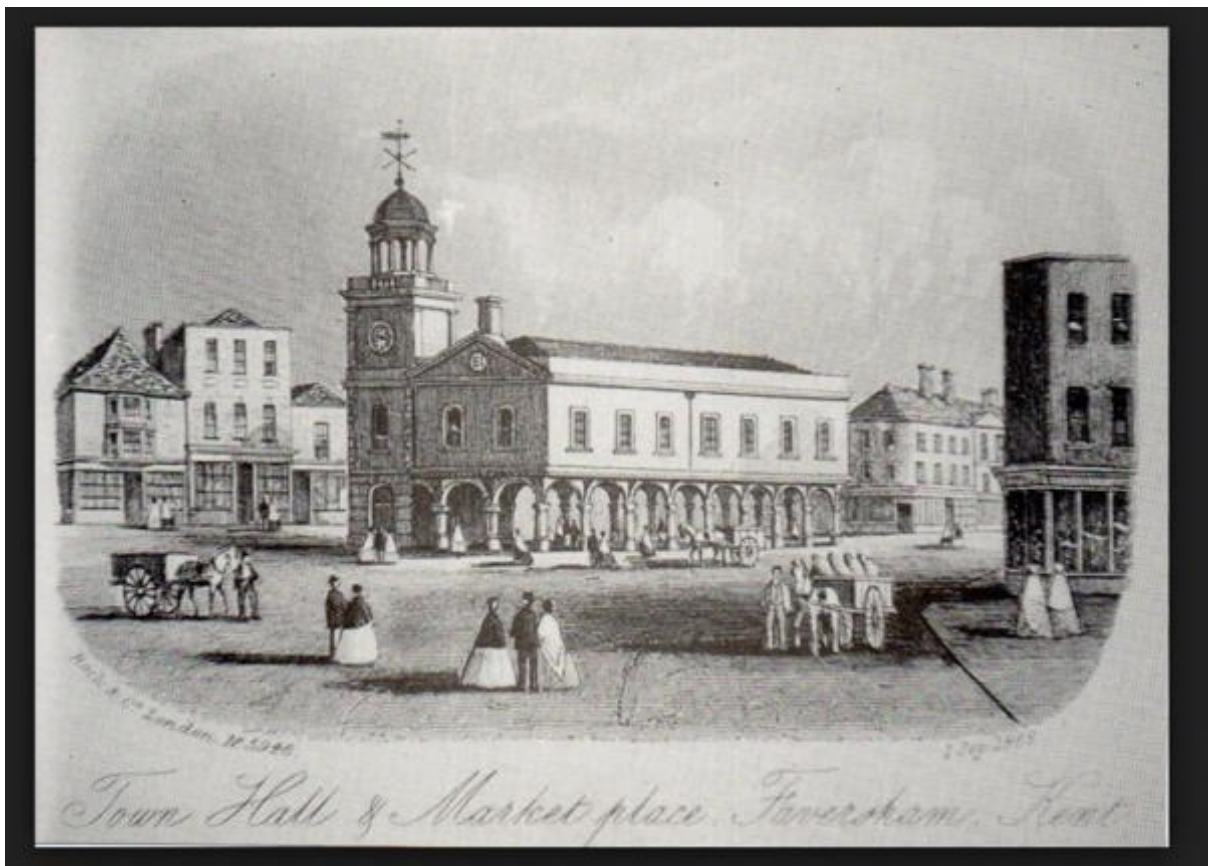
Note chimney stack now removed.
